SBCC Survey of Existing Buildings and Retrofit Plan

SANTA BARBARA CITY COLLEGE SEISMIC SURVEY

PRELIMINARY REPORT

May 31, 2023

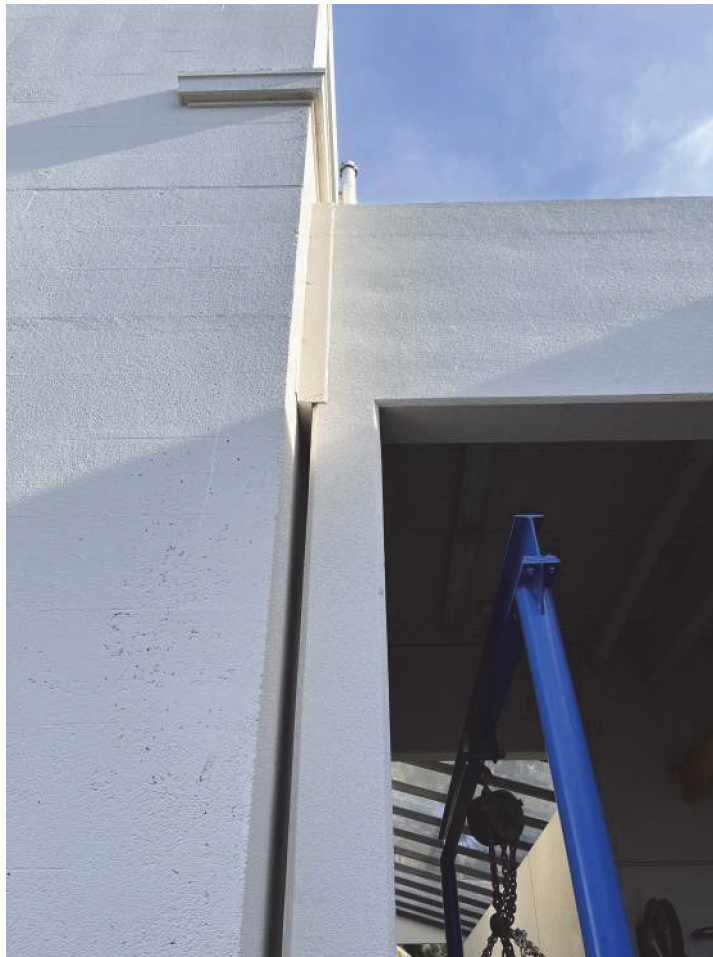
Seismic Separation @ 0001.1

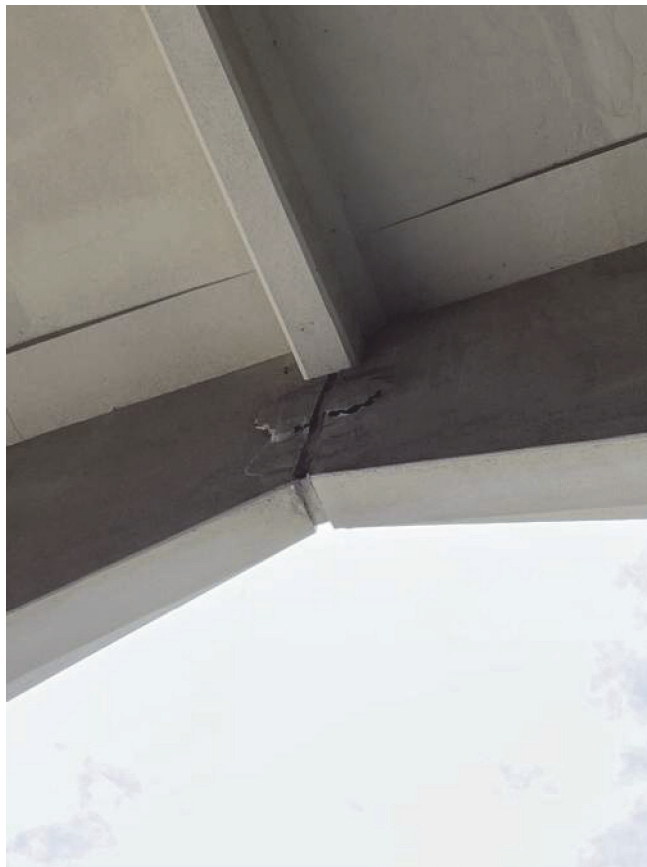
SUBJECT: 0024 – Student Services

Water Damage at Connection of Precast Concrete Exterior Columns

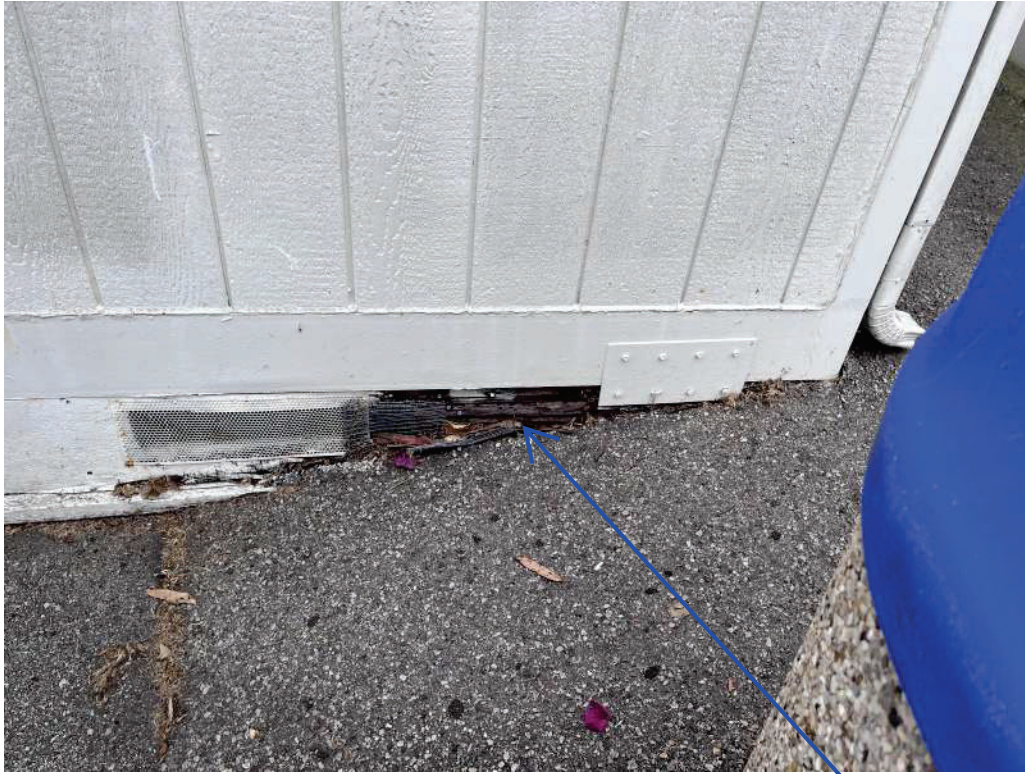
Pressure Treated Wood Sill and Rim

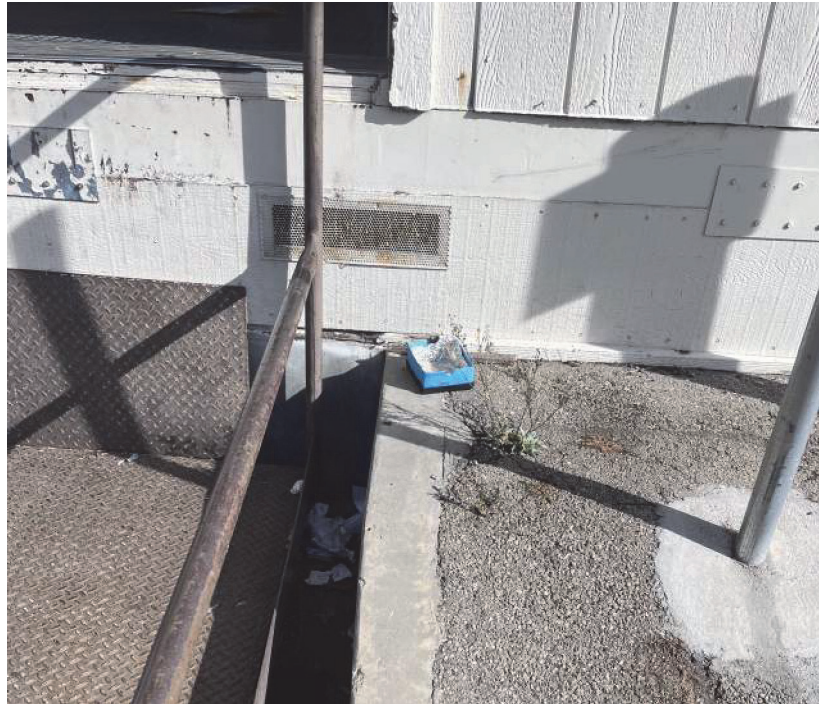
Deterioration of Wood Sill-On-Ground

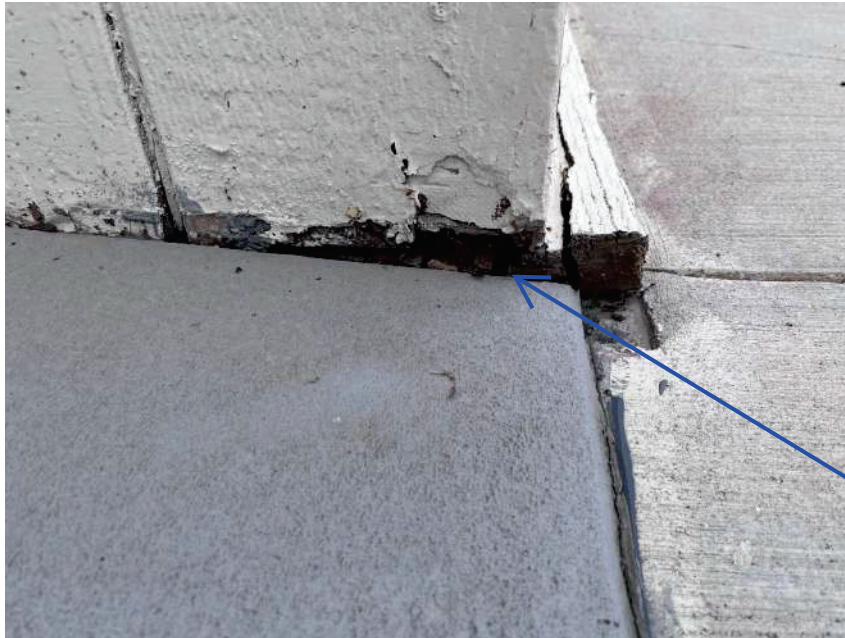
T&S/DRT: Crushing and deterioration of wood sill-on-ground

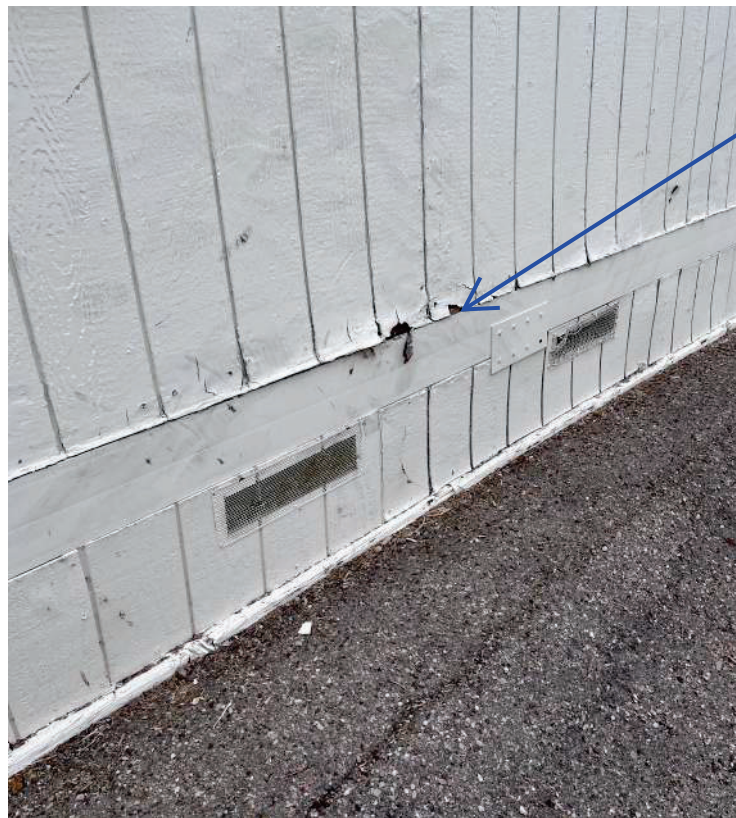
T&S/DRT: Crushing and warping of joint

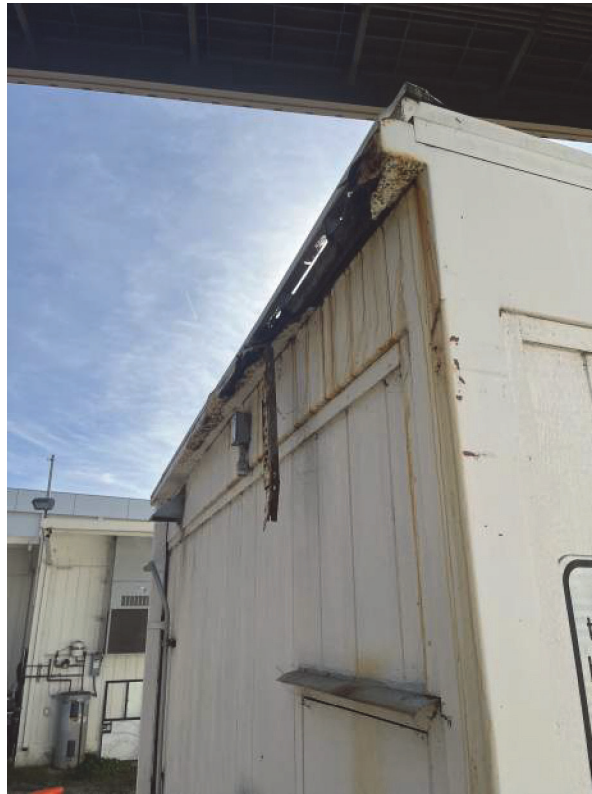
Significant Damage to Gutter

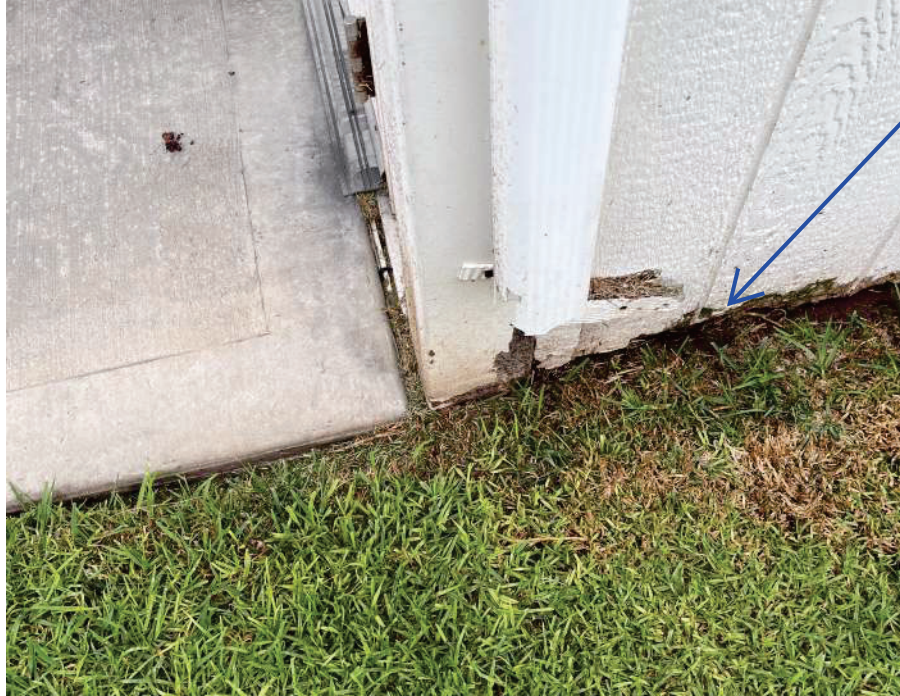
T&S/DRT: Rot and deterioration of wood sill-on-ground

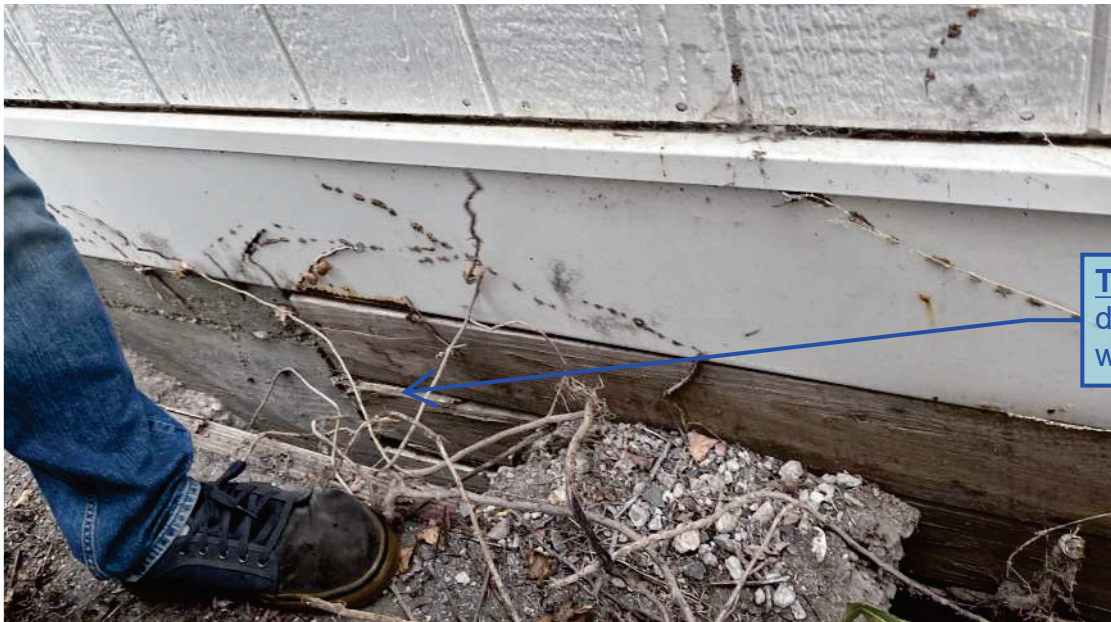
T&S/DRT: Rot and deterioration of wood blockout

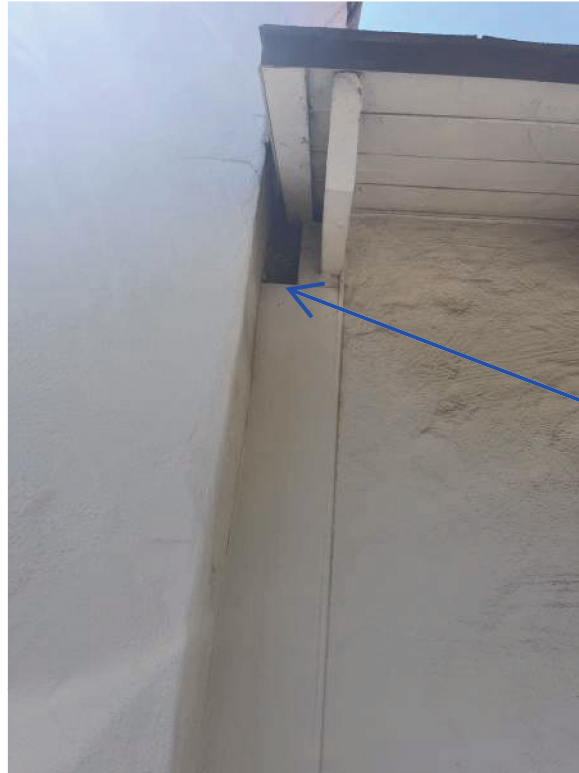
T&S/DRT: Limited clear distance to adjacent building and building end condition cause a potential for pounding

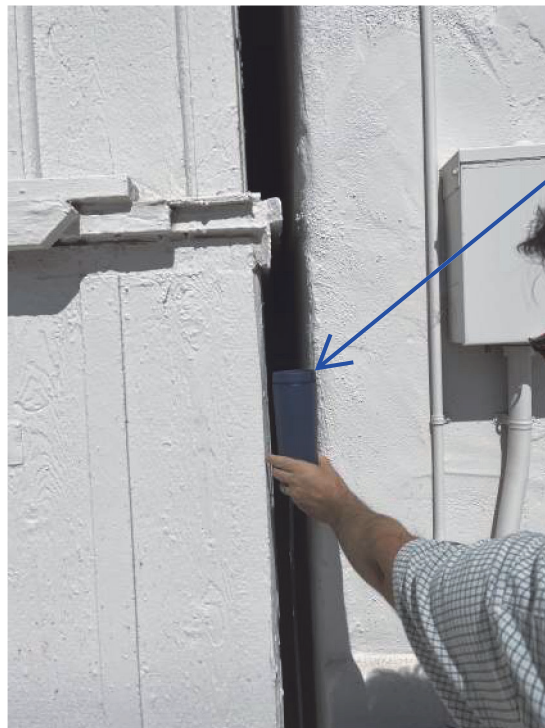
T&S/DRT: Limited clear distance to adjacent building and building end condition cause a potential for pounding

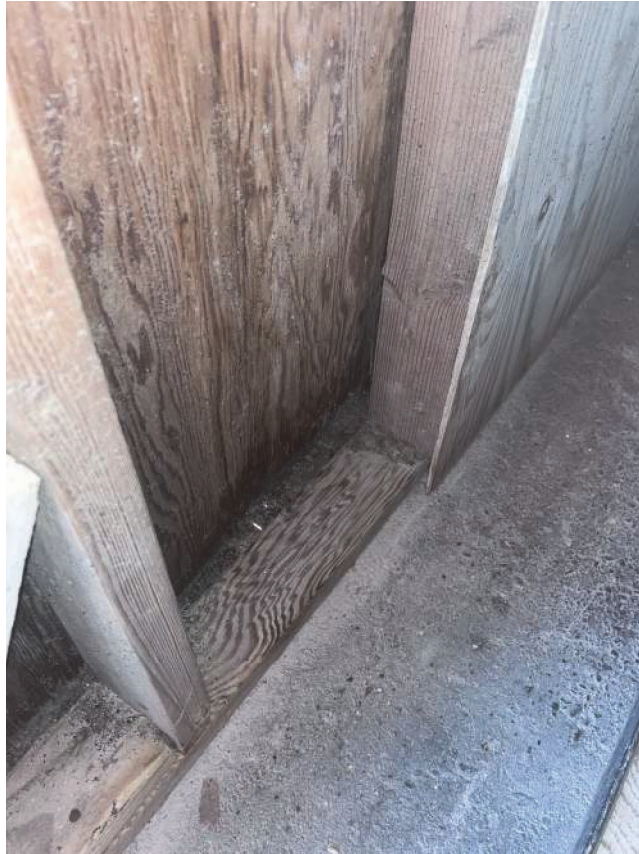
Building 37 - Damage to Sill Plate

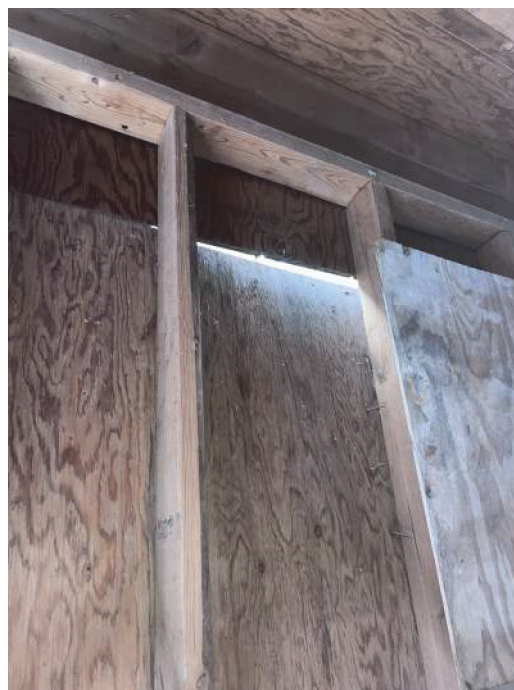
Building 37 - Damage to Exterior Wall Sheathing

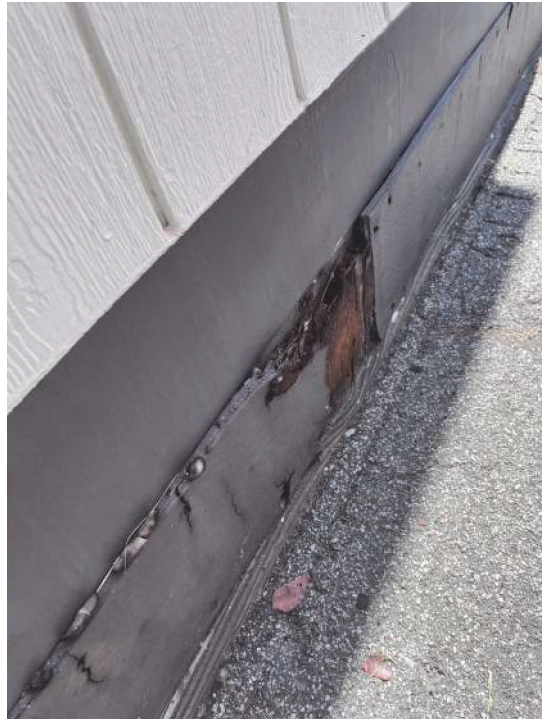
Damage to Plywood Skirting

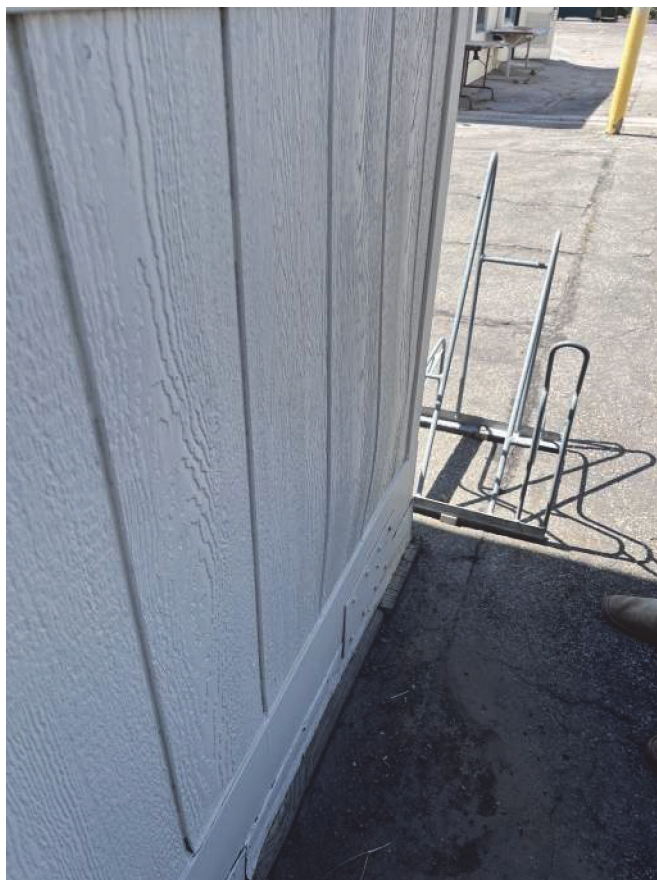
Damage to Metal Framing @ Foundation

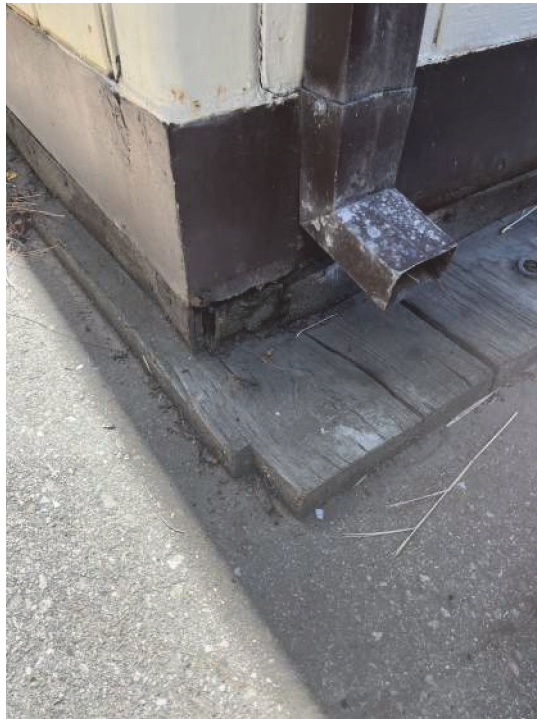
Damage to Plywood Skirting

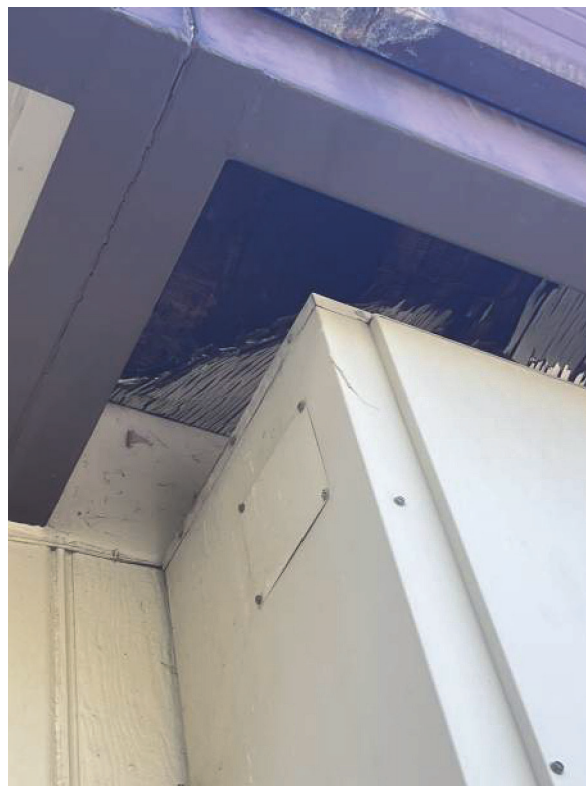
Damage to Plywood Roof Sheathing

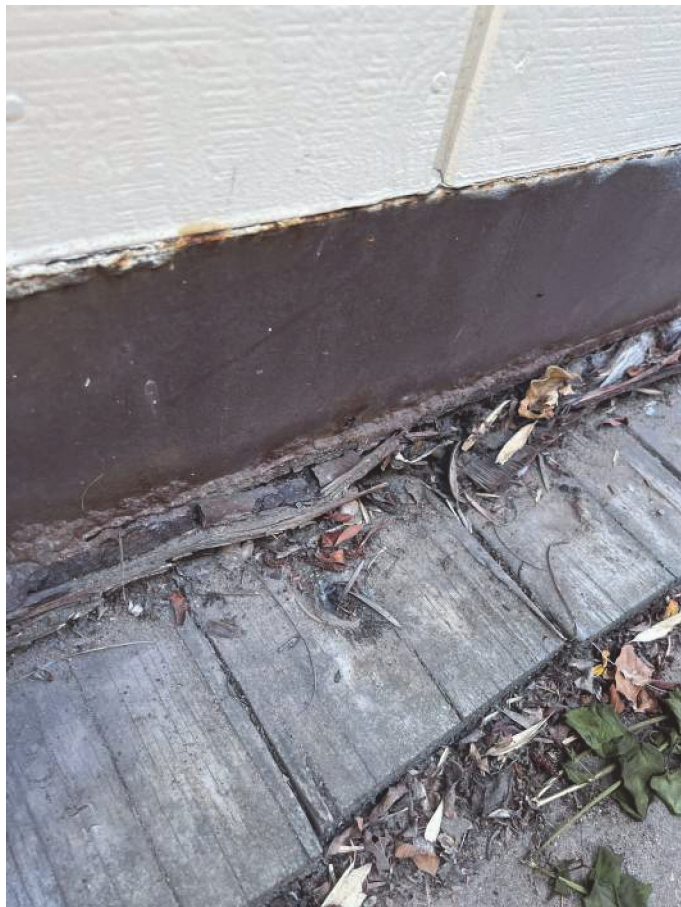
SUBJECT: 30 – Relocatable Classroom

Damage to Plywood Skirting/Wood Sill

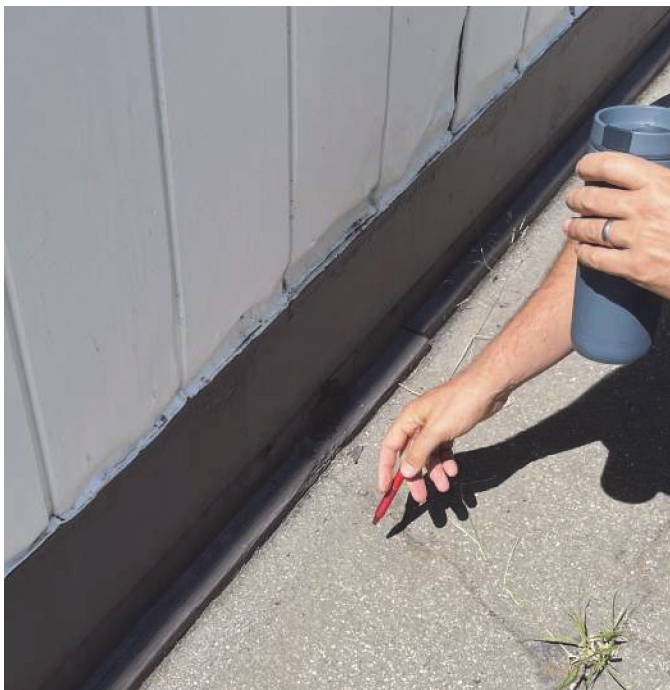
SUBJECT: 31 – Relocatable Classroom

Damage to Plywood Skirting

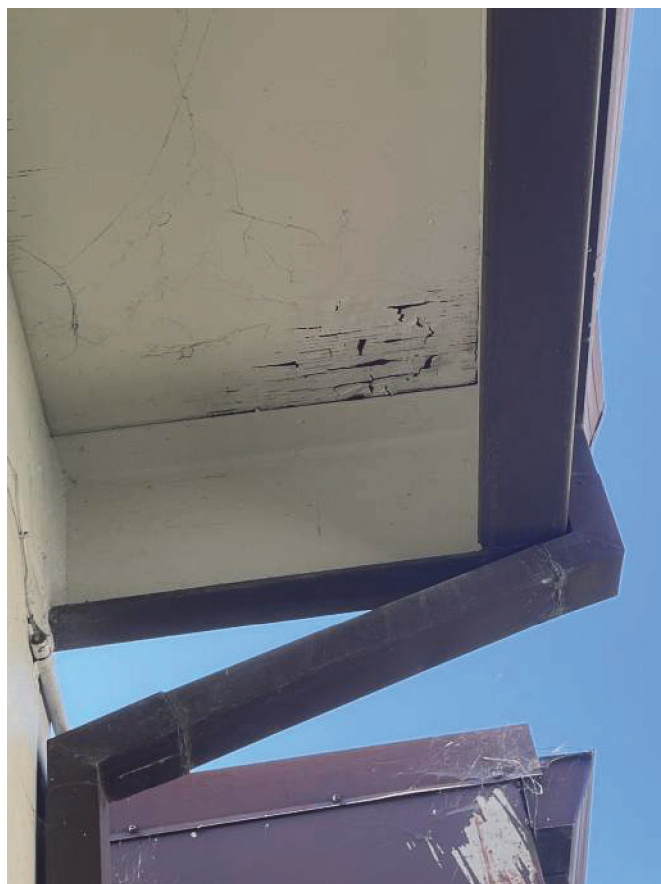
Damage to Plywood Roof Sheathing

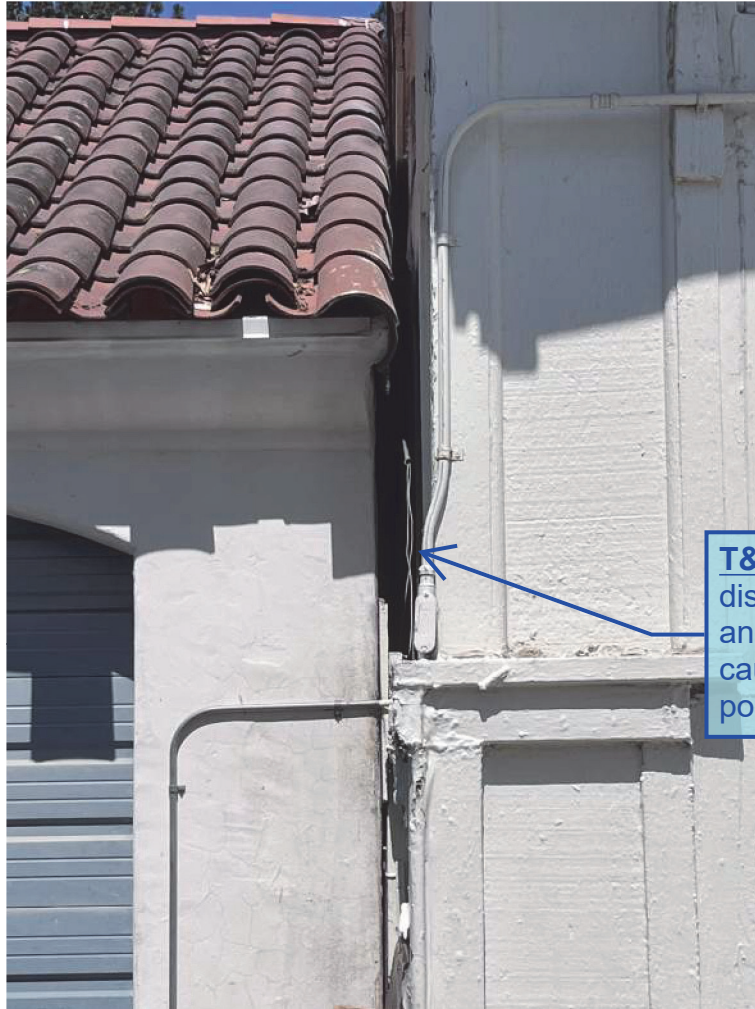
T&S/DRT: Limited clear distance to adjacent building and building end condition cause a potential for pounding

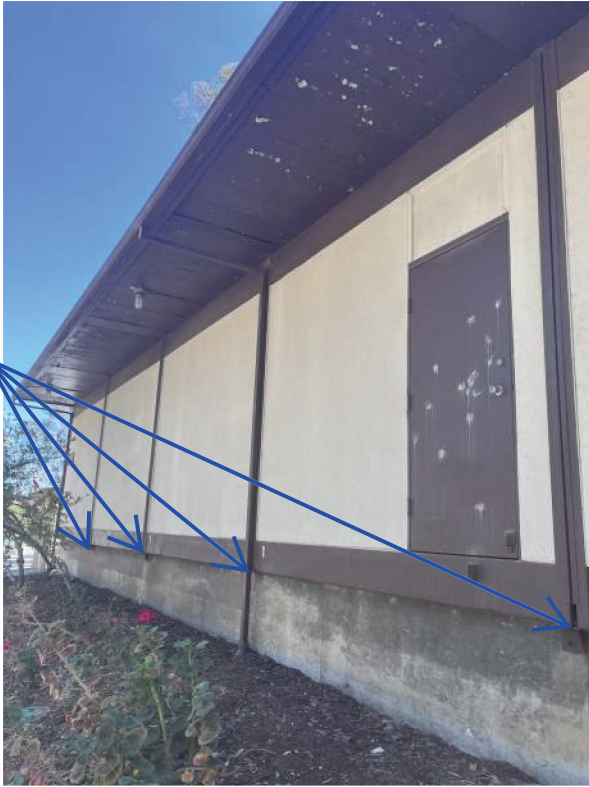
T&S/DRT: Steel angle w/
(2) AB @ ~ 12'-0" on
north/south perimeter are
the only visible form of
structure anchorage

Inadequate Footing Anchorage

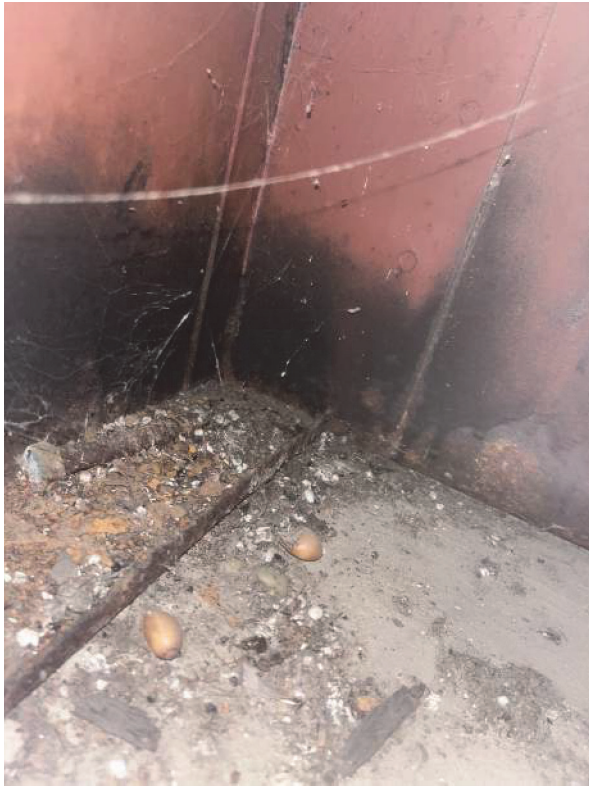
Slight Deterioration of Floor System on Footing

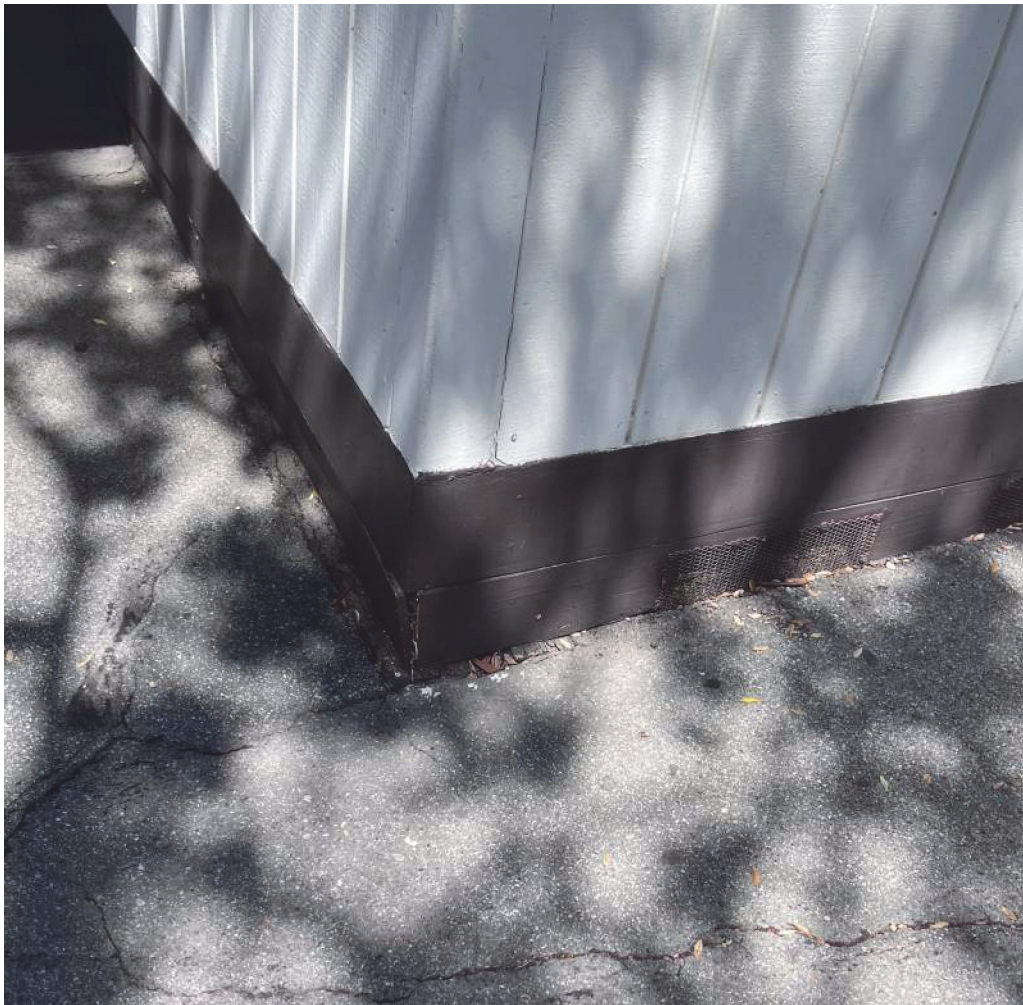
SUBJECT: 0032 – Relocatable 27

*Slight Deterioration of Wood Sill-On-Ground
and Cripple Wall Sheathing*

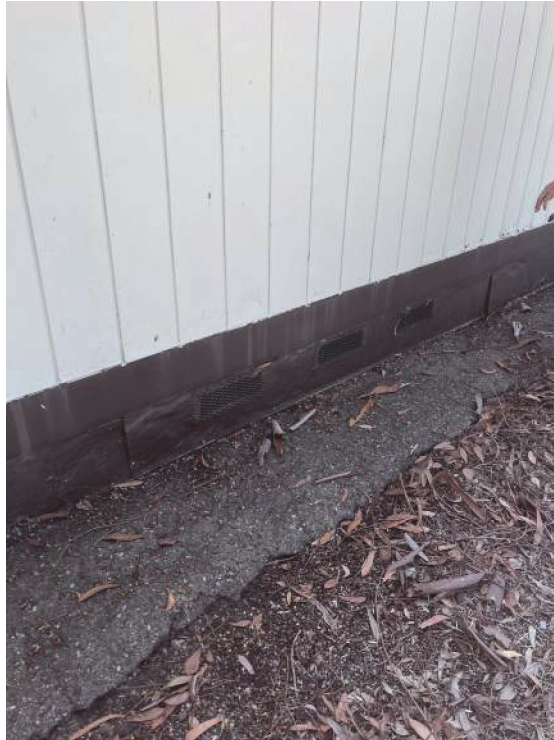
Slight Deterioration Cripple Wall Sheathing

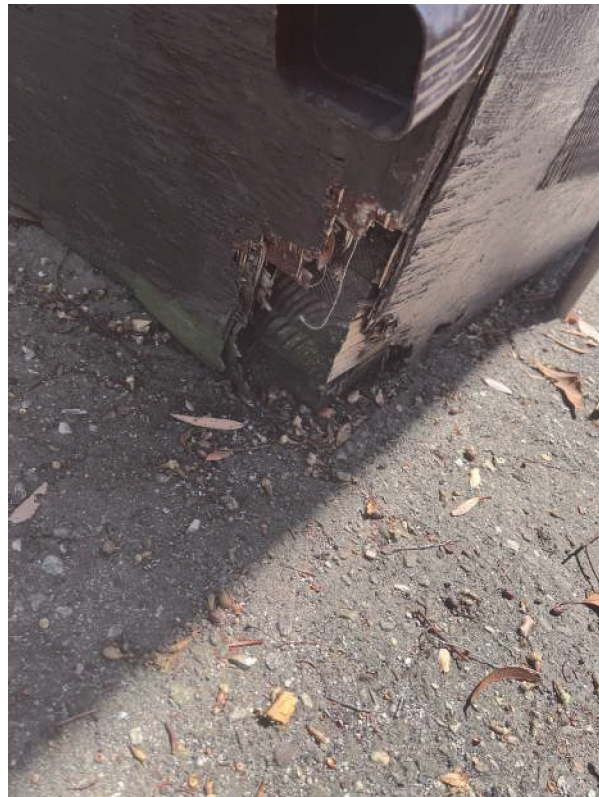
Slight Deterioration Cripple Wall Sheathing

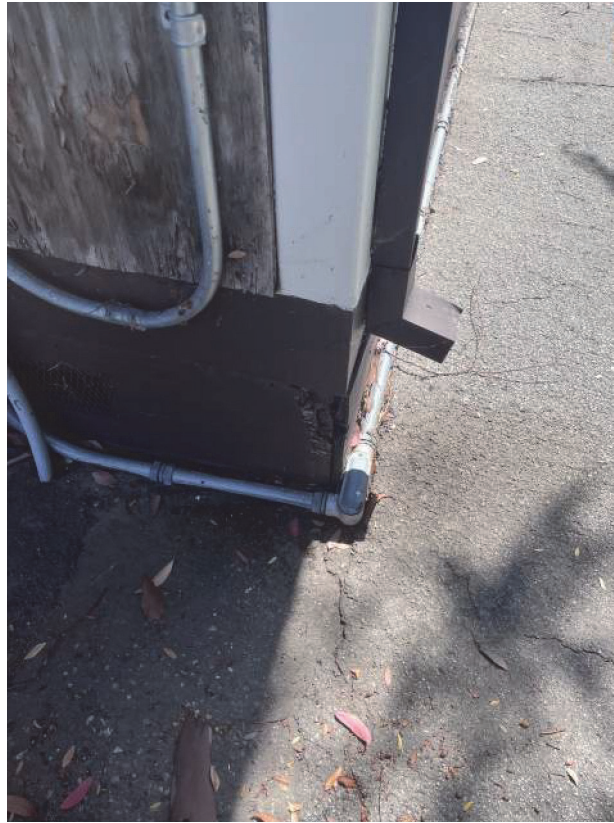
SUBJECT: 0035 – Relocatable 28

*Slight Deterioration to Cripple
Wall Sheathing*

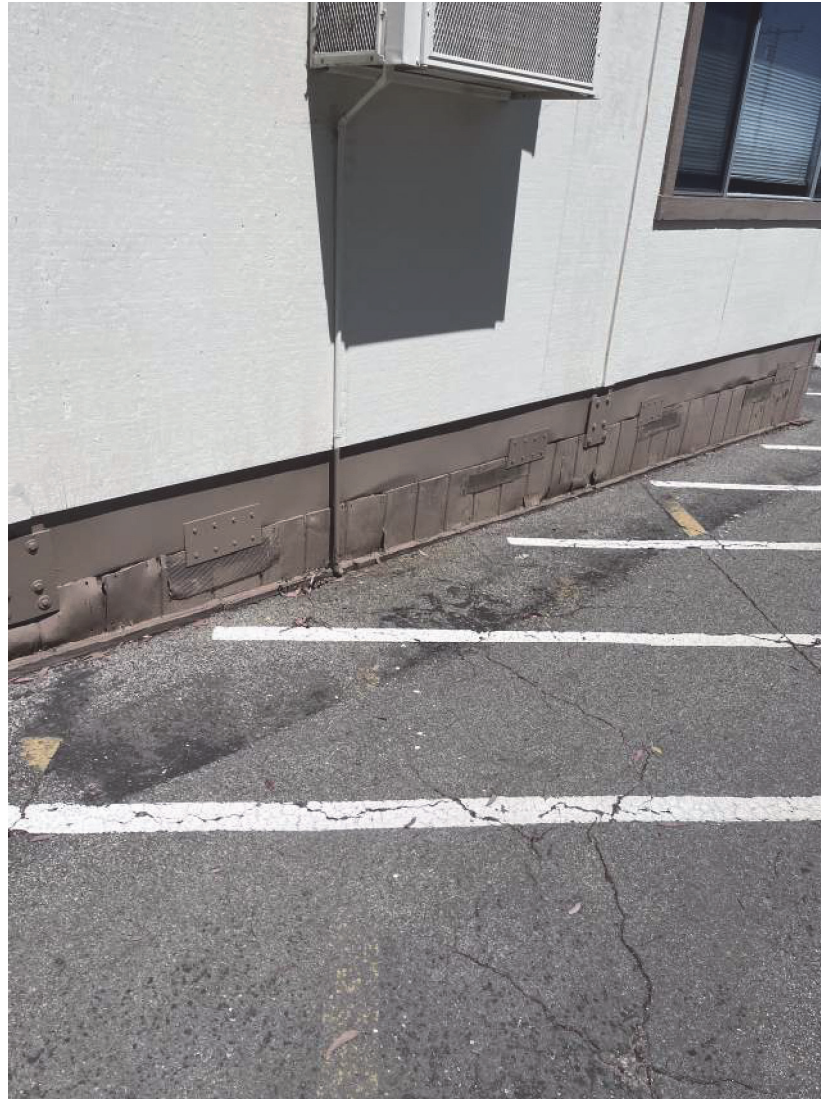
Slight Deterioration of Cripple Wall Sheathing
