SBCC Survey of Existing Buildings and Retrofit Plan

SANTA BARBARA CITY COLLEGE SEISMIC SURVEY

PRELIMINARY REPORT

May 31, 2023

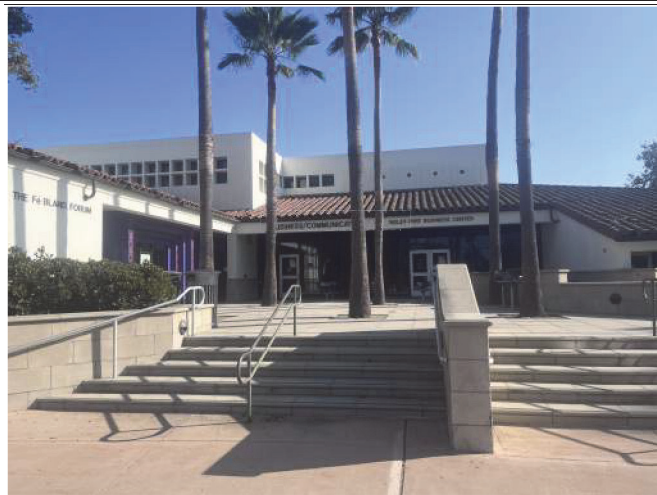
COMMENTS:
Three story steel framed structure with steel and metal deck roof, light gage steel walls, supported on a slab-on-grade foundation system. Tube steel braced frames over concrete shear walls seismic system. Concrete filled metal deck floor diaphragm and bare metal deck sheathing roof diaphragm. In-plane setbacks of the seismic system were discovered along gridlines 2 & 7 and out-of-plane setbacks were discovered along gridlines 3.2, 3.4, 7, H, G, B, and diagonal between B & B.1 (concrete deck used as force distribution). A re-entrant corner exists in the North-West corner of the structure.

Site Conditions Observed:
No observed signs of significant structural damage or deterioration.

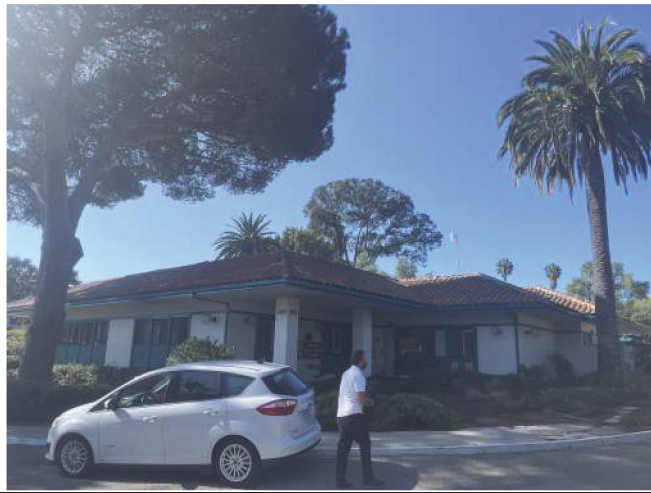
COMMENTS:
Single-story structure with wood-framed roof and walls supported on a slab-on-grade foundation system. Wood shearwall seismic system, with plaster for shear resistance. 1x diagonal sheathing for roof diaphragm. Small re-entrant corners exist on each corner of the building (less than 20ft).
Site Conditions Observed:
No observed signs of significant structural damage or deterioration.

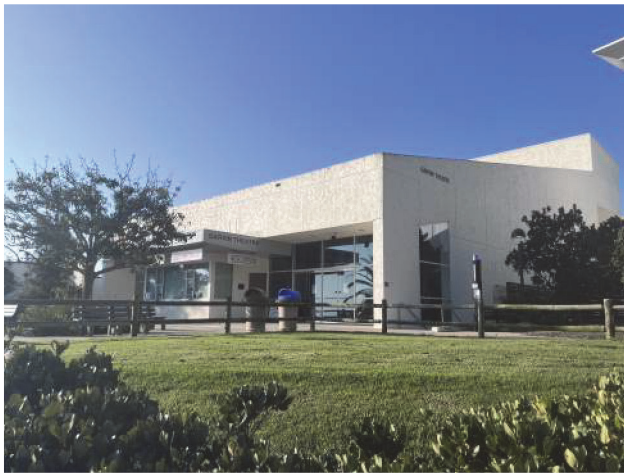
Site Conditions Observed:
No observed signs of significant structural damage or deterioration.

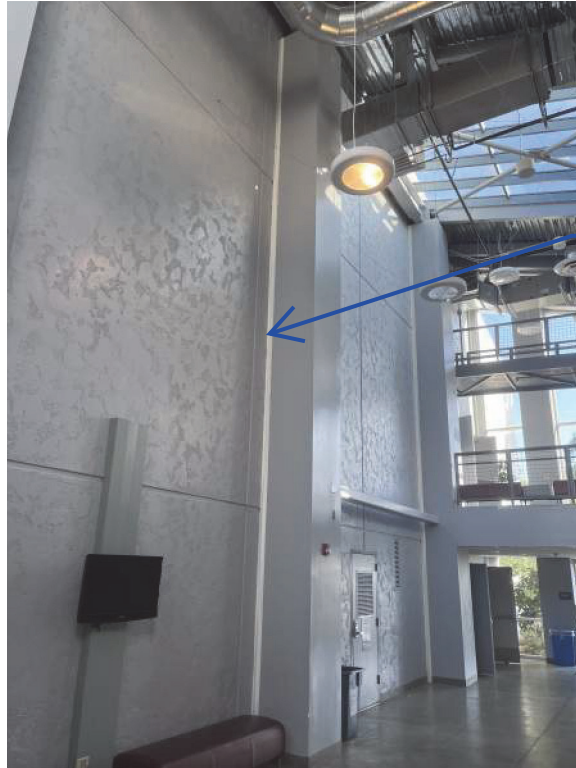
Seismic Separation @ 0007

T&S/DRT:
Expansion Joint

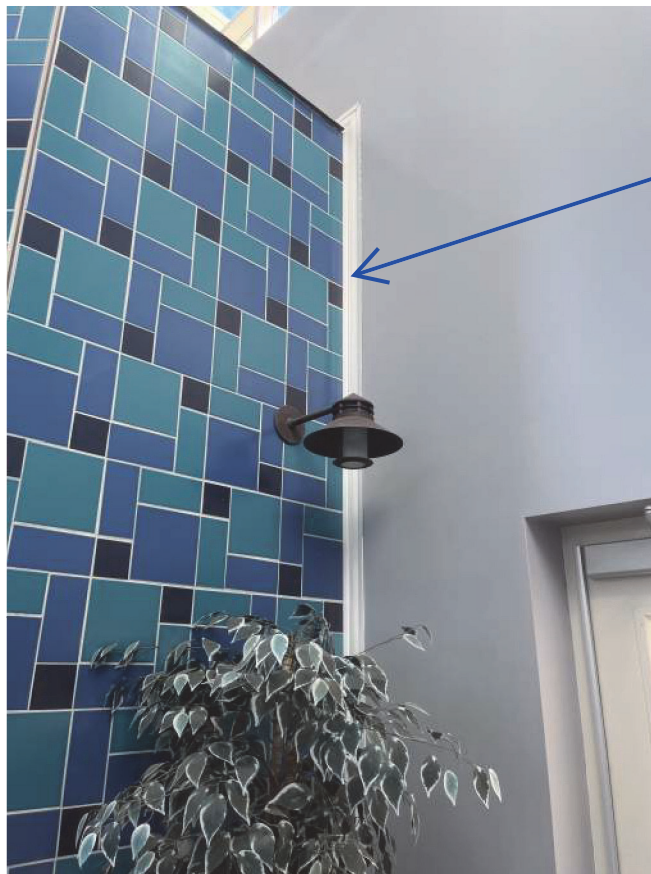
Seismic Separation @ 0007

T&S/DRT:
Expansion Joint

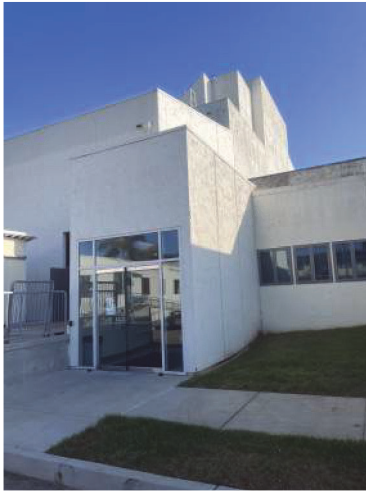
COMMENTS:
Single-story structure with steel tube framed roof and light gage steel stud walls supported on a grade-beam & slab-on-grade foundation system. Steel tube cantilever column seismic system. Seismic separation joints were present on all sides shared with the existing building. Light gage metal decking for roof diaphragm.
Site Conditions Observed:
No observed signs of significant structural damage or deterioration.
 Additional sketches or comments on separate page

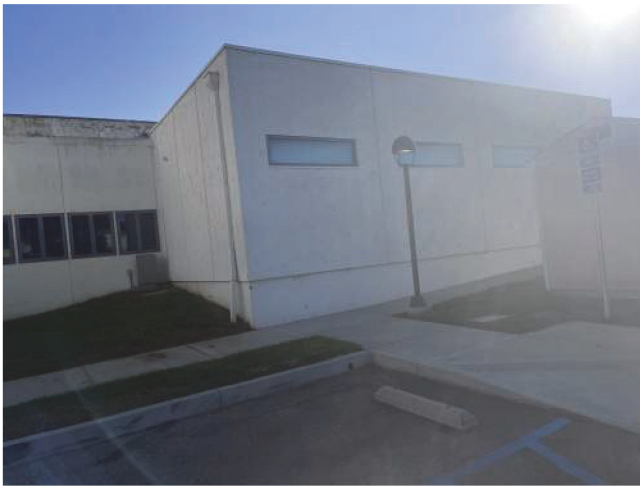
Seismic Separation @ 0007

COMMENTS:
Single-story structure with steel wide flange framed roof and light gage steel stud walls supported on a slab-on-grade foundation system. Light gage steel shearwall seismic system, with plywood for shear resistance. A seismic separation joint was present on the side shared with the existing building. Light gage metal decking for roof diaphragm.

Site Conditions Observed:
No observed signs of significant structural damage or deterioration.

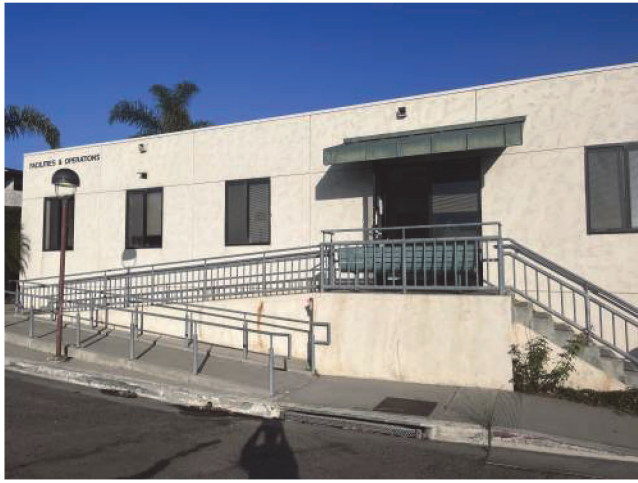
COMMENTS:
Single-story structure with wood-framed roof and walls supported on a slab-on-grade foundation system. Wood shearwall seismic system, with plywood for shear resistance. Plywood sheathing for roof diaphragm.
Site Conditions Observed:
No observed signs of significant structural damage or deterioration.

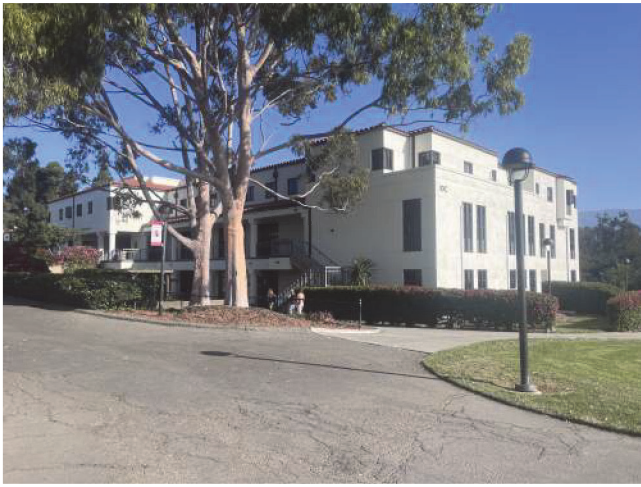
COMMENTS:
Three-story structure with reinforced CMU walls at the first and second floor, steel framed structure above with light gage steel walls, and supported on a slab-on-grade foundation system. Wide Flange steel moment frame over reinforced masonry shear walls for the seismic system. Concrete filled metal deck floor diaphragm and bare metal deck roof diaphragm.

Site Conditions Observed:
No observed signs of significant structural damage or deterioration.

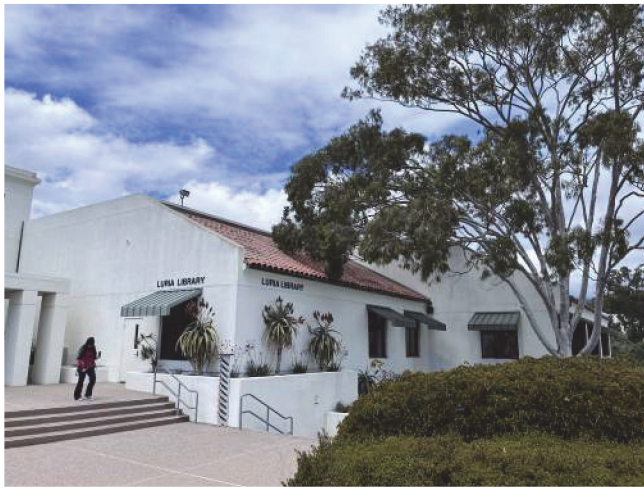
COMMENTS:
Two-story structure with steel wide flanged framed roof, concrete waffle slab floor and steel stud framed walls supported on a slab-on-grade foundation system. Steel moment frame above reinforced concrete foundation wall seismic system. Light gage metal deck sheathing for roof diaphragm, reinforced concrete slab for floor diaphragm. Seismic separation was present between the library and learning resource center. Along gridline 9 & B, a moment frame on the upper floor is outboard of concrete walls below, causing a severe out-of-plane setback. Along gridline C, a moment frame does not stack over a concrete wall below causing an in-plane setback. Re-entrant corners exists on north-east, north-west and south-west corners of the structure.

Site Conditions Observed:
No observed signs of significant structural damage or deterioration.
 Additional sketches or comments on separate page

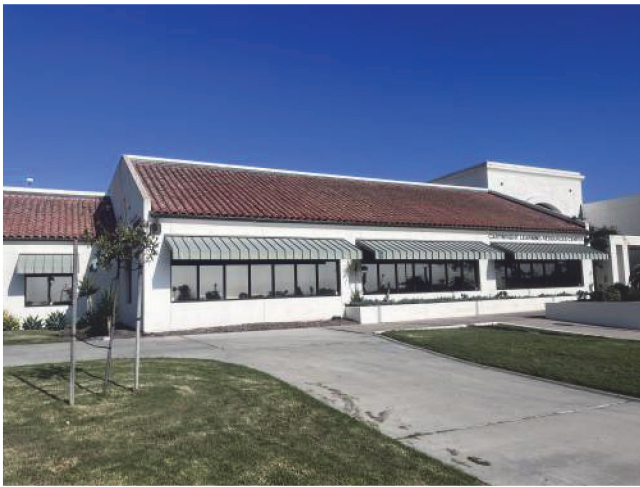
COMMENTS:
Single-story structure with steel wide flanged roof and steel stud framed walls supported on a slab-on-grade foundation system. Steel moment frame seismic system. Light gage metal deck sheathing for roof diaphragm. Seismic separation was present between the library and learning resource center. Re-entrant corners exists on south-west and south-east corners of the structure.

Site Conditions Observed:
No observed signs of significant structural damage or deterioration.

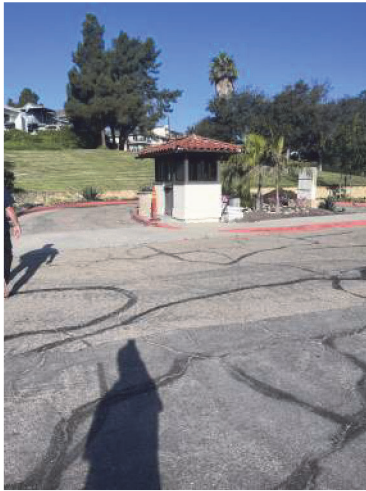
COMMENTS:
Single-story structure with wood-framed roof and walls supported on a slab-on-grade foundation system. Wood shearwall seismic system, with plywood for shear resistance. Plywood sheathing for roof diaphragm.
Site Conditions Observed:
No observed signs of significant structural damage or deterioration.

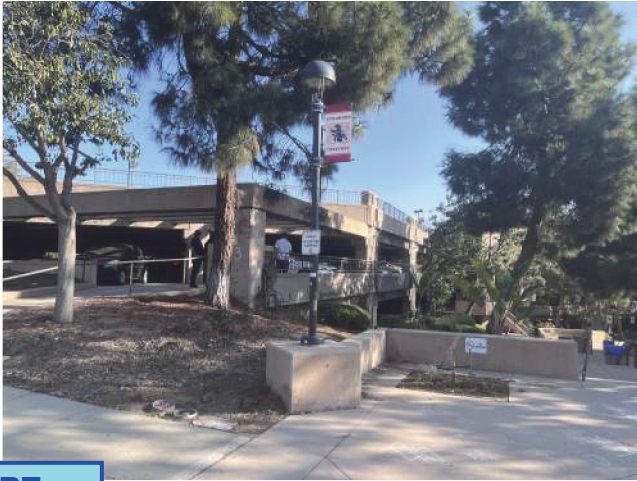
COMMENTS:
Four-story structure with pre-cast concrete framed floor and roof supported on a slab-on-grade foundation system. Reinforced cast-in-place concrete shearwall seismic system. Reinforced concrete topping slab for diaphragm.
Site Conditions Observed:
No observed signs of significant structural damage or deterioration.
*Inadequate precast concrete beam ties to walls/interior beams
 Additional sketches or comments on separate page

Comments: Inadequate ties from interior precast concrete beams to concrete walls/exterior precast concrete beams is justification for moderate vertical irregularity.

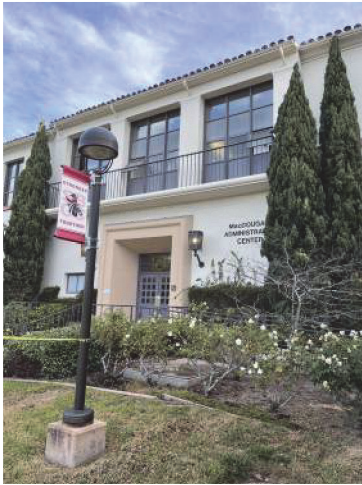
COMMENTS:
Two-story structure with reinforced concrete slab over reinforced concrete joists for roof and floor and cast-in-place concrete walls/columns supported on a slab-on-grade foundation system. Reinforced concrete shearwall seismic system. Reinforced concrete deck over steel/concrete joists for roof and floor diaphragm. Along the west wall line of the corridor over arcade that runs north south, a concrete shear wall does not stack over a wall below and an in-plane offset is present. The roof of the auto shop located at the south west wing of the structure does not line up with the roof or second floor level, and as such a split level irregularity occurs. Re-entrant corners exist on the north-east and north-west corners of the structure.

Site Conditions Observed:
No observed signs of significant structural damage or deterioration.
 Additional sketches or comments on separate page

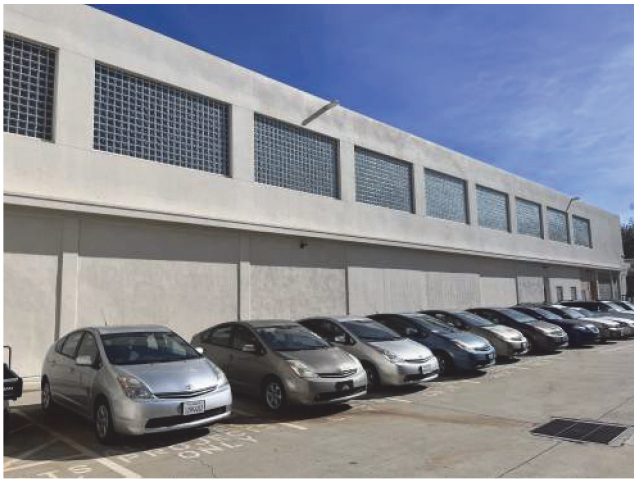
COMMENTS:
Two-story structure with reinforced concrete slab over reinforced concrete joists for roof and floor and cast-in-place concrete walls/columns supported on a slab-on-grade foundation system. Reinforced concrete shearwall seismic system. Reinforced concrete deck for roof and floor diaphragm. Along the south face of the structure, bottom floor, a series of large openings (some of which have been infilled) exist with a concrete shear wall above that does not stack over a structural wall below causing an in-plane offset. Also along this line, a serious lack of seismic walls at the bottom floor cause a potential for a torsional irregularity.

Site Conditions Observed:
No observed signs of significant structural damage or deterioration.
 Additional sketches or comments on separate page

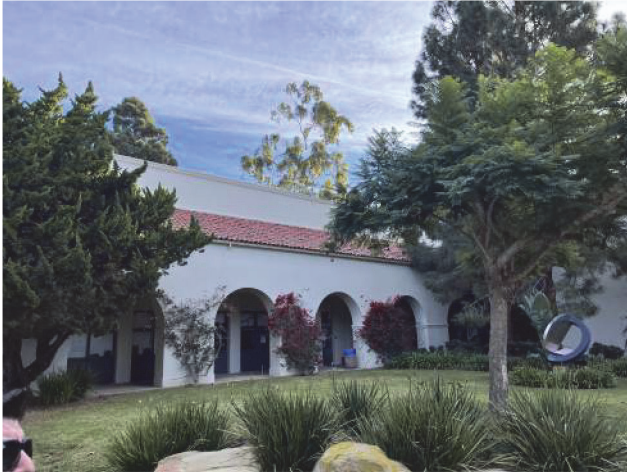
COMMENTS:
 Two-story structure with reinforced concrete slab over reinforced concrete joists for roof and cast-in-place concrete walls/columns supported on a slab-on-grade foundation system. Reinforced concrete shearwall seismic system. Reinforced concrete deck for roof and floor diaphragm. Concrete shear walls along gridline C at the upper floor are inboard of concrete shear walls below, causing an out-of-plane setback. The lack of seismic strength at the upper floor along gridline B, and the lack of seismic strength at the lower floor along gridline D both cause a torsional irregularity. The seismic separation to the main administration building is only 2" (less than 2" per story or 4" total) and the building sits at the end of a block of structures, so pounding is still a concern.

Site Conditions Observed:
 No observed signs of significant structural damage or deterioration.
 Additional sketches or comments on separate page

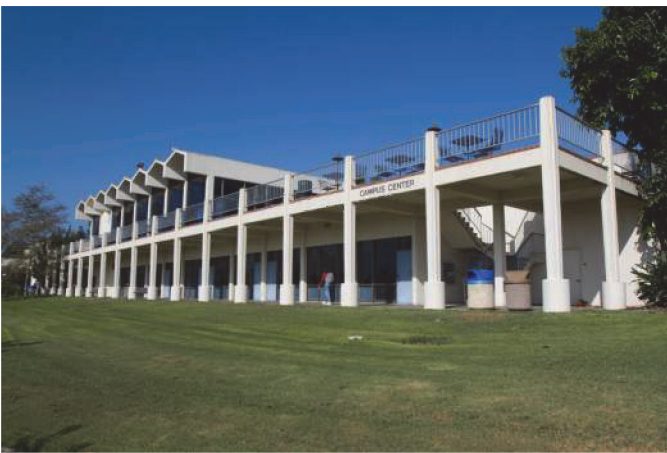
COMMENTS:
Two-story structure with cast-in-place concrete floor, pre-cast concrete roof and cast-in-place concrete walls supported on a slab-on-grade foundation system. Reinforced concrete shearwall seismic system. Reinforced concrete topping slab for roof diaphragm and reinforced concrete deck for floor diaphragm. A concrete shear wall at the upper floor located along gridline 2 is inboard of the concrete shear walls at the level below, causing an out-of-plane setback. There are re-entrant corners at the east and west corners of the upper structure.

Site Conditions Observed:
No observed signs of significant structural damage or deterioration.

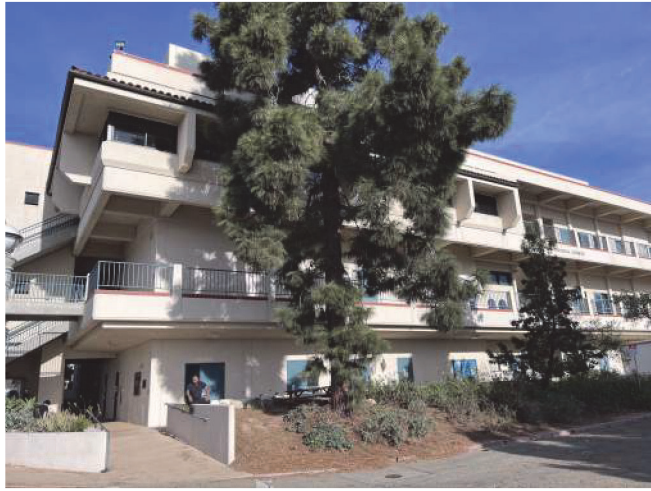
COMMENTS:
Three-story structure with concrete encased steel-framed floor and roof and steel columns supported on a slab-on-grade foundation system. Tube steel braced frame over reinforced fully grouted masonry shearwall seismic system. Reinforced concrete slab for floor and roof diaphragm. A comprehensive seismic retrofit occurred in 2000, along with an exterior stair addition.

Site Conditions Observed:
No observed signs of significant structural damage or deterioration.

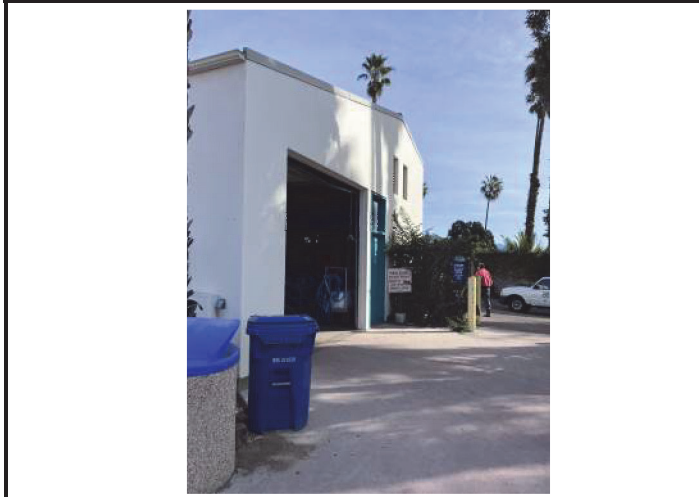
COMMENTS:
Single-story structure with wood-framed roof and walls supported on a slab-on-grade foundation system. Wood shearwall seismic system. Plywood sheathing for roof diaphragm. Smaller re-entrant corners exist on the north-east and south-east corners of the structure (less than 20ft).
Site Conditions Observed:
No observed signs of significant structural damage or deterioration.
 Additional sketches or comments on separate page

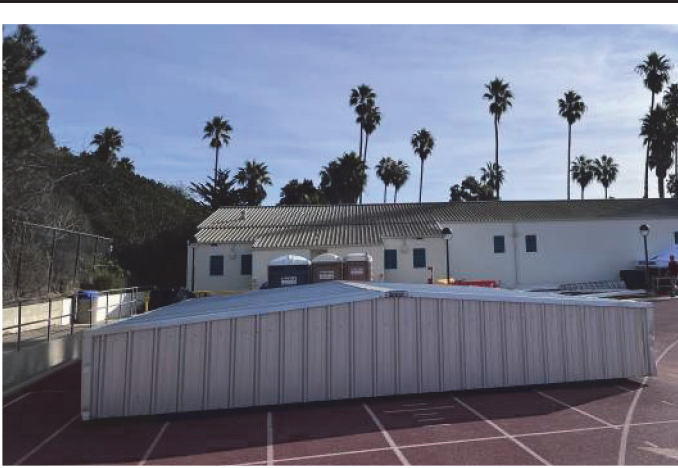
COMMENTS:
 Single-story structure with wood-framed roof and masonry walls supported on a slab-on-grade foundation system. Reinforced masonry shearwall seismic system. Plywood sheathing for roof diaphragm. Smaller re-entrant corners exist on the north-west and south-west corners of the structure (less than 20ft).
 Site Conditions Observed:
 No observed signs of significant structural damage or deterioration.
 Additional sketches or comments on separate page

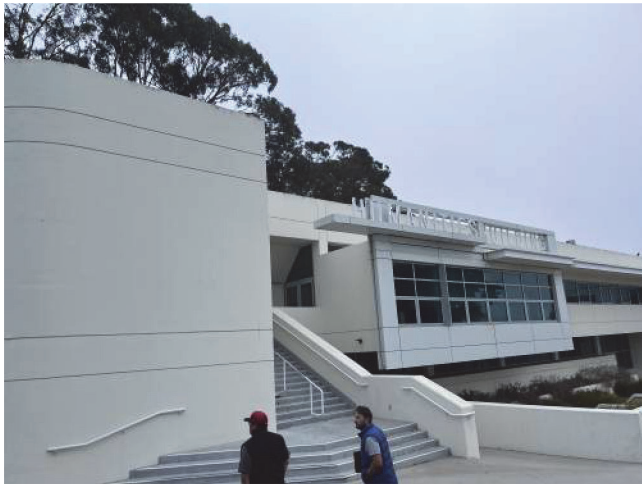
COMMENTS:
Three-story structure with steel-framed roof and light gage steel walls supported on a slab-on-grade foundation system. Reinforced concrete shearwall seismic system. Reinforced concrete deck for roof and floor diaphragm. Along gridline C between gridlines 5 & 7 and 8 & 9, a concrete shear wall at the upper level does not stack with a wall below causing an in-plane offset irregularity. Along gridline 15, a concrete shearwall at the upper level is inboard of the concrete shearwalls at the lower level causing an out-of-plane setback.

Site Conditions Observed:
No observed signs of significant structural damage or deterioration.

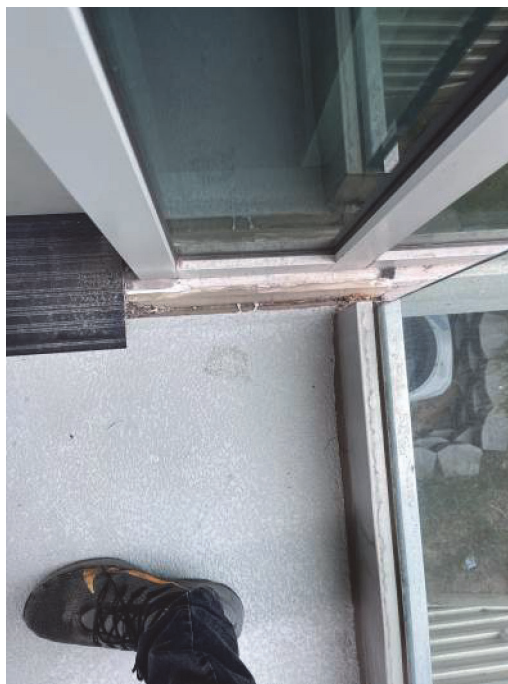
Seismic Separation @ Stair

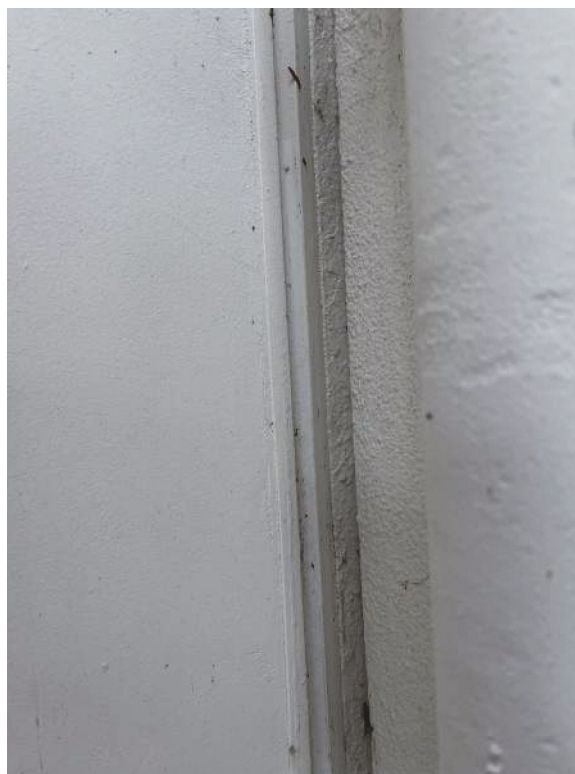
Seismic Separation @ Storage

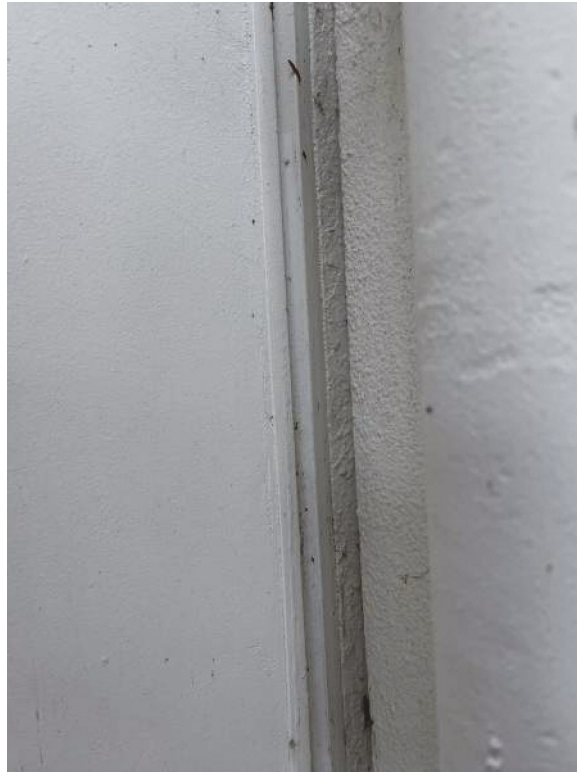
Seismic Separation @ Storage

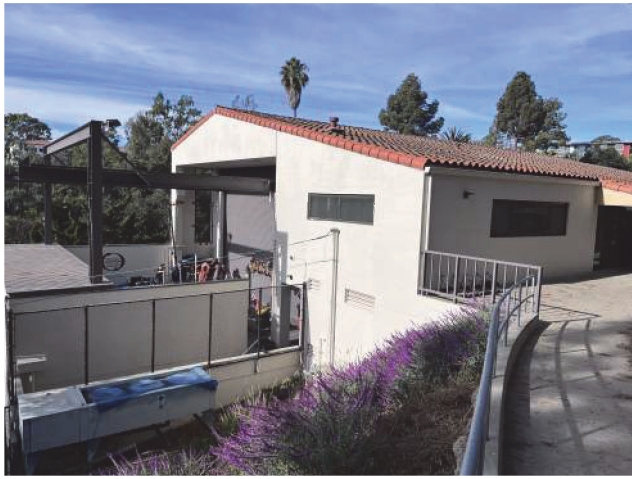
COMMENTS:
Two-story above basement structure with cast-in-place concrete pan floor and reinforced masonry walls supported on a slab-on-grade foundation system. Reinforced masonry shearwall seismic system. Plywood sheathing over wood/steel joists for roof diaphragm.

Site Conditions Observed:
No observed signs of significant structural damage or deterioration.

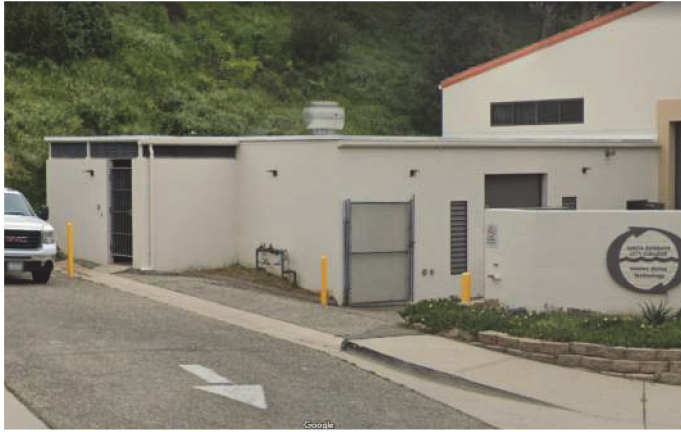
COMMENTS:
Single-story structure with steel roof framing and reinforced masonry walls supported on a slab-on-grade foundation system. Reinforced masonry shearwall and steel braced frame seismic system. Corrugated metal sheathing for roof diaphragm. A small re-entrant corner exists on the north-west corner of the structure (less than 20ft).

Site Conditions Observed:
No observed signs of significant structural damage or deterioration.

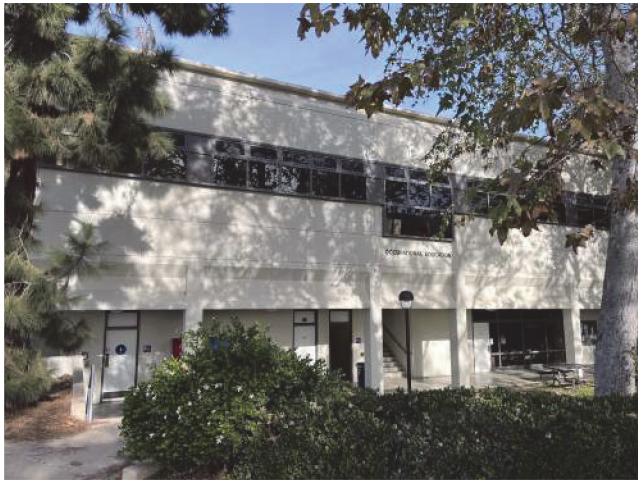
Exterior Falling Hazards: Unbraced Chimneys Heavy Cladding or Heavy Veneer
 Parapets Appendages
 Other: Skylight & Roof Infill Between Admin. & Transmission Lab

COMMENTS:
Two-story structure with cast-in-place reinforced concrete slab over reinforced concrete joists floor and cast-in-place concrete walls supported on a slab-on-grade foundation system. Reinforced concrete shearwall seismic system. Reinforced concrete pan deck over steel joists for roof diaphragm. A 33ft shearwall along gridline 'F' on the upper floor is slightly inboard and offset from concrete shear walls below causing a minor out-of-plane setback and minor in-plane offset.

Site Conditions Observed:
No observed signs of significant structural damage or deterioration.
 Additional sketches or comments on separate page

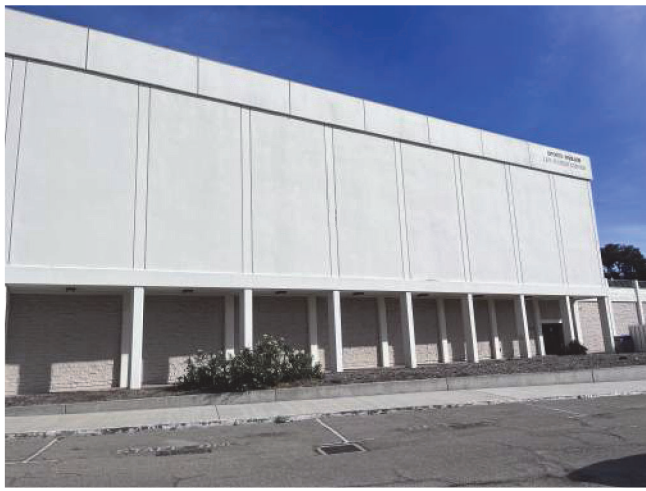
COMMENTS:
Two-story structure with concrete beam framed floor and steel joist framed roof and pre-cast concrete walls supported on a slab-on-grade foundation system. Reinforced pre-cast concrete shearwall seismic system. Reinforced concrete for roof/floor diaphragm. The south face of the structure has precast concrete shearwalls at the upper floors that are outboard of concrete shear walls below causing a severe out-of-plane setback irregularity.

Site Conditions Observed:
No observed signs of significant structural damage or deterioration.

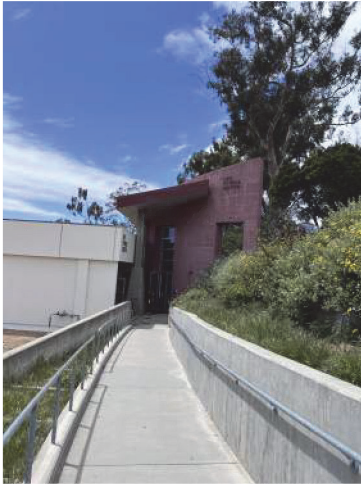
COMMENTS:
 Two-story structure with steel-framed floor and roof and light gage steel stud walls supported on a pile and grade-beam foundation system. Tube steel braced frames at the bottom floor and wideflange steel moment frames at the upper floor for seismic system. Concrete fill over steel decking for floor diaphragm and bare metal decking for roof diaphragm.
 Site Conditions Observed:
 No observed signs of significant structural damage or deterioration.
 Additional sketches or comments on separate page

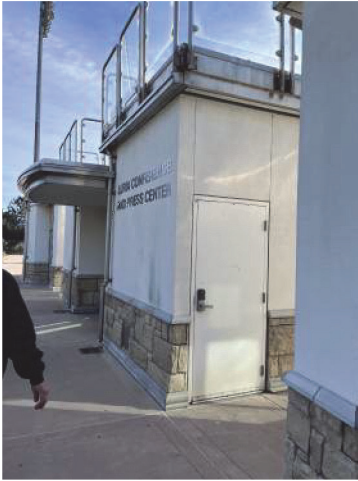
COMMENTS:
Single-story structure with steel framed roof and light gage steel walls supported on slab-on-grade foundation system. Tube steel braced frame & wideflange steel moment frame seismic system. Concrete fill over light gage corrugated steel for roof diaphragm.

Site Conditions Observed:
No observed signs of significant structural damage or deterioration.

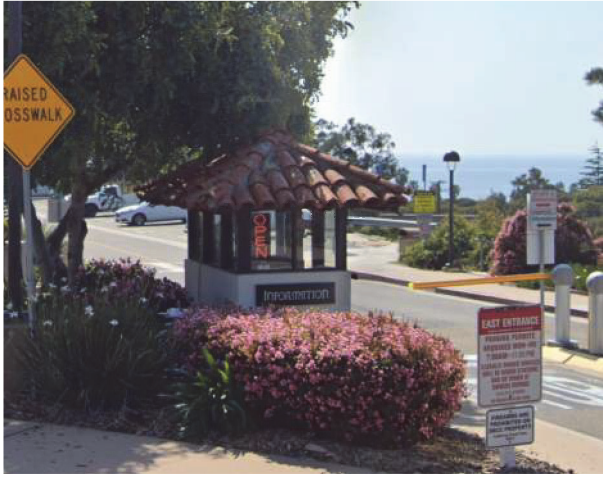
COMMENTS:
 Single-story structure with wood-framed roof and walls supported on a slab-on-grade foundation system. Wood shearwall seismic system, with plywood for shear resistance. Plywood sheathing for roof diaphragm.
 Site Conditions Observed:
 No observed signs of significant structural damage or deterioration.

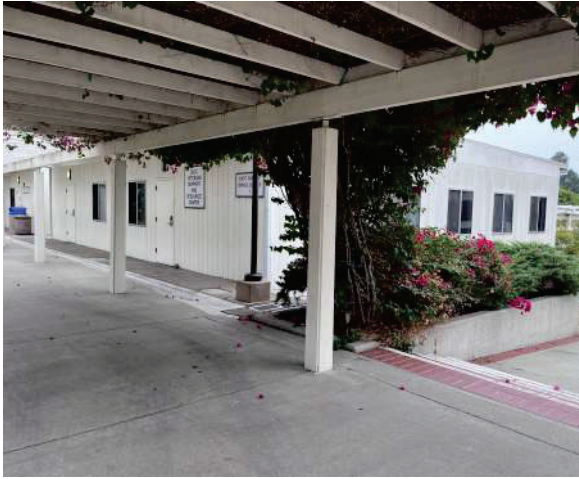
COMMENTS:
Single-story structure with light gage steel framed roof, floor, and walls supported on pressure treated lumber plates. Light gage steel with plywood shearwall seismic system. Standing seam steel sheathing for roof diaphragm.
Site Conditions Observed:
No observed signs of significant structural damage or deterioration.

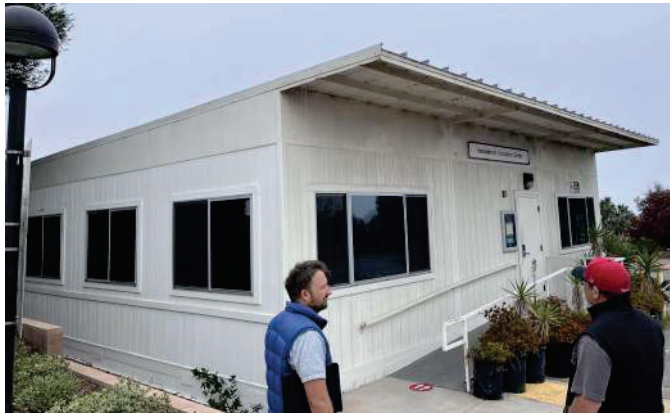
Pressure Treated Wood Sill and Rim

COMMENTS:
Single-story structure with light gage steel framed roof, floor, and walls supported on pressure treated lumber plates. Light gage steel with plywood shearwall seismic system. Standing seam steel sheathing for roof diaphragm.
Site Conditions Observed:
Significant deterioration of the wood rim and wood sill-on-ground was observed.

T&S/DRT:
Significant rot damage to rim and sill plate.

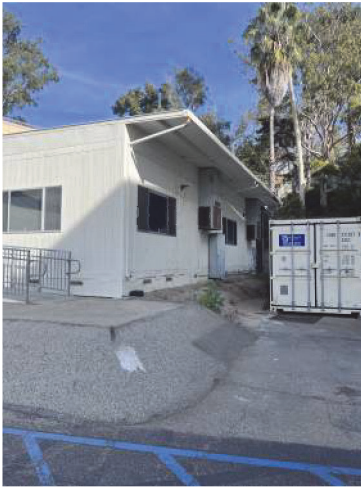
Deterioration of Wood Sill-On-Ground

Site Conditions Observed:
Deterioration of the wood sill-on-ground was observed.

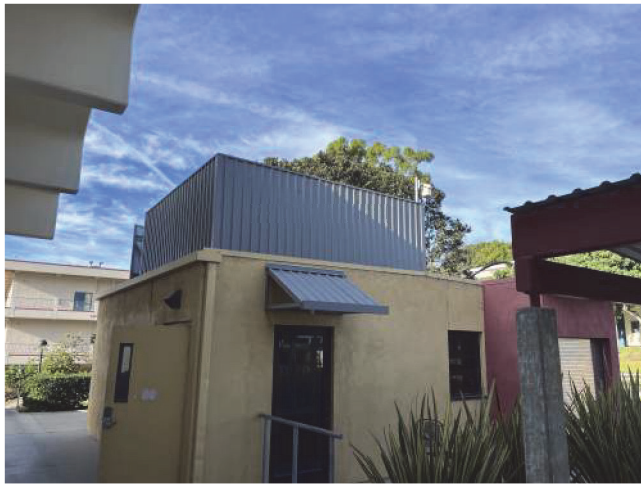
Wall Framing to Floor Framing Joint

Site Conditions Observed:
Wood sill-on-ground was observed to be crushing and deteriorating. Additionally, crushing and warping at the joint of wall to floor framing was observed.

T&S/DRT: Crushing and warping of joint

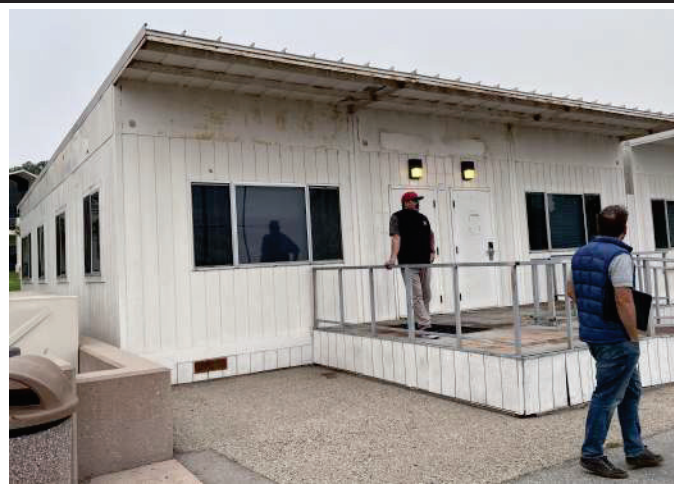
COMMENTS:
Single-story structure with light gage steel framed roof and walls supported on pressure treated wood on grade foundation system. Plywood sheathed light gage steel shearwall seismic system. Light gage corrugated steel sheathing for roof diaphragm.

Site Conditions Observed:
No observed signs of significant structural damage or deterioration.

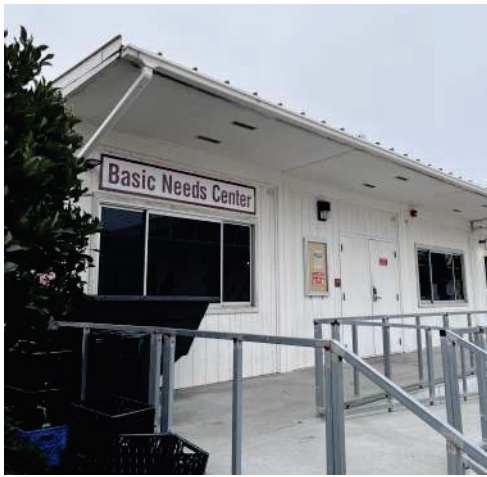
COMMENTS:
Single-story structure with light gage steel framed roof and walls supported on pressure treated wood on grade foundation system. Plywood sheathed light gage steel shearwall seismic system. Light gage corrugated steel sheathing for roof diaphragm.
Site Conditions Observed:
No observed signs of significant structural damage or deterioration.

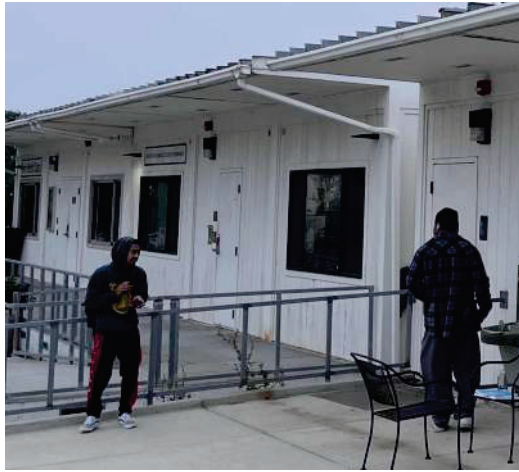
COMMENTS:
Single-story structure with light gage steel framed roof and walls supported on pressure treated wood on grade foundation system. Plywood sheathed light gage steel shearwall seismic system. Light gage corrugated steel sheathing for roof diaphragm.
Site Conditions Observed:
No observed signs of significant structural damage or deterioration.

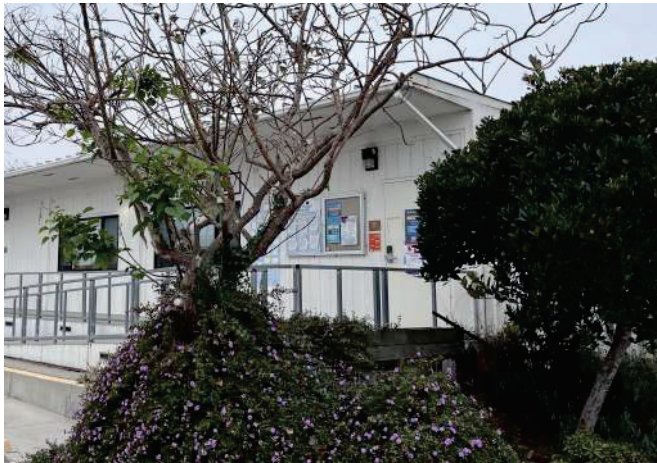
Site Conditions Observed:
Significant damage to the gutter on the rear side of the structure was observed. More specifically, the gutter was missing and rust/water damage was present along the entire fascia of the roof.

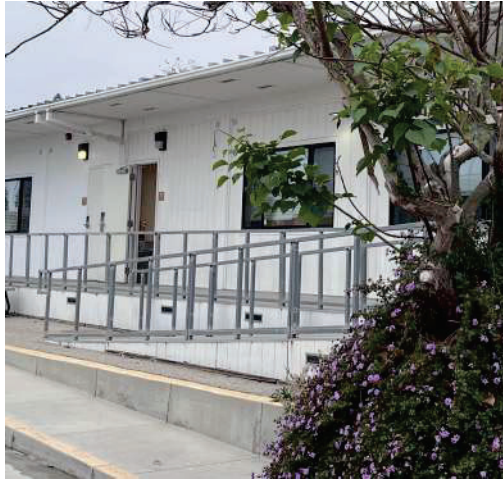
Site Conditions Observed:
Significant damage to the gutter on the rear side of the structure was observed. More specifically, the gutter was missing and rust/water damage was present along the entire fascia of the roof.

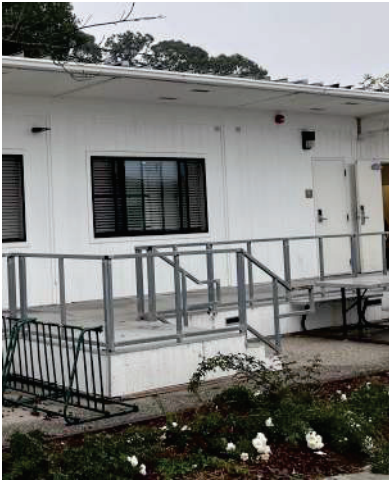
Site Conditions Observed:
Significant damage to the gutter on the rear side of the structure was observed. More specifically, the gutter was missing and rust/water damage was present along the entire fascia of the roof.

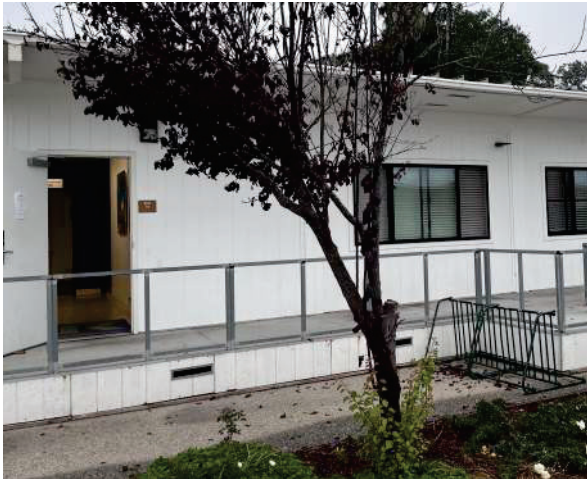
COMMENTS:
Single-story structure with light gage steel framed roof, floor, and walls supported on pressure treated lumber plates. Light gage steel with plywood shearwall seismic system. Standing seam steel sheathing for roof diaphragm.
Site Conditions Observed:
Significant damage to the gutter on the rear side of the structure was observed. More specifically, the gutter was missing and rust/water damage was present along the entire fascia of the roof.
 Additional sketches or comments on separate page

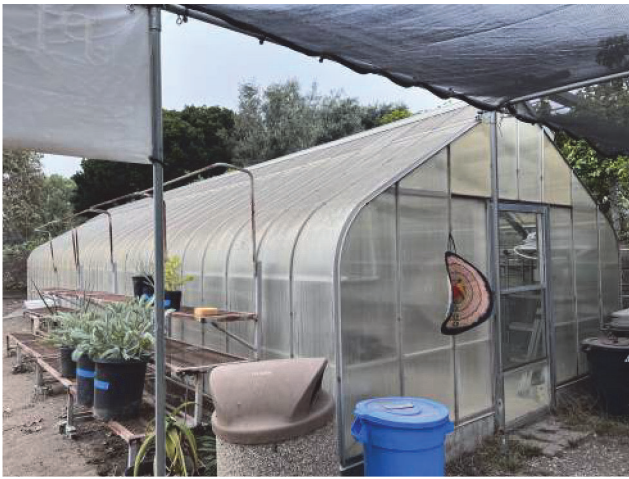
COMMENTS:
Single-story structure with light gage steel framed roof and walls supported on a slab-on-grade foundation system. Steel moment frame seismic system. Light gage metal bracing with plexi-glass sheathing for roof diaphragm.
Site Conditions Observed:
No observed signs of significant structural damage or deterioration.

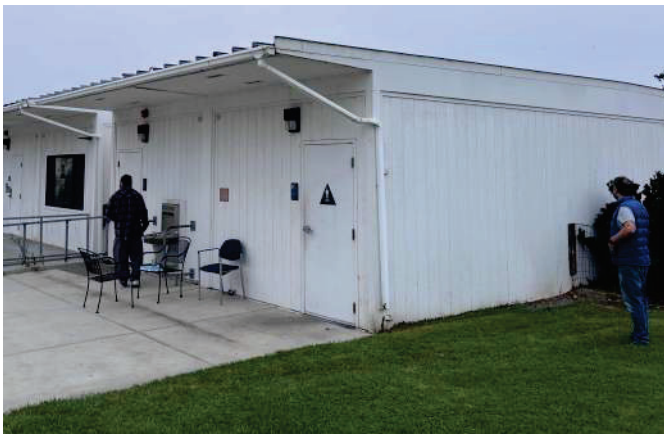
COMMENTS:
Single-story structure with light gage steel framed roof, floor, and walls supported on pressure treated lumber plates. Light gage steel with plywood shearwall seismic system. Standing seam steel sheathing for roof diaphragm.
Site Conditions Observed:
Significant damage to the gutter on the rear side of the structure was observed. Rust/water damage was present along the entire fascia of the roof.

Significant Damage to Gutter

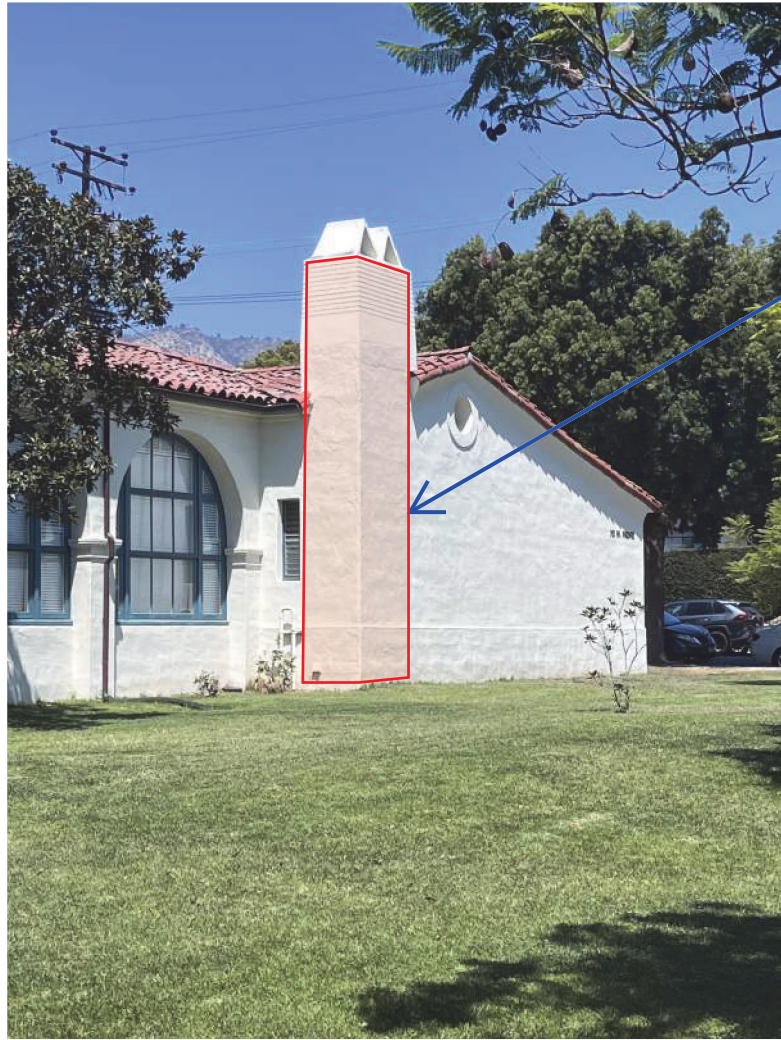
East Corner of Structure

T&S/DRT: Unbraced masonry chimney

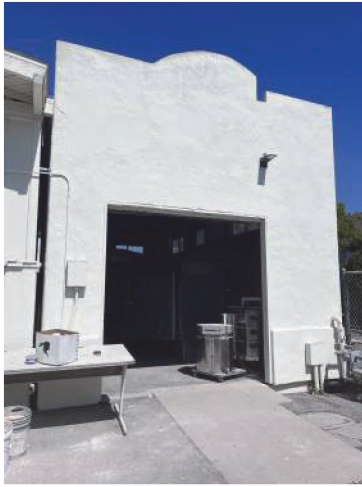
T&S/DRT: Limited clear distance to adjacent building and building end condition cause a potential for pounding

Clearance to Adjacent Structure

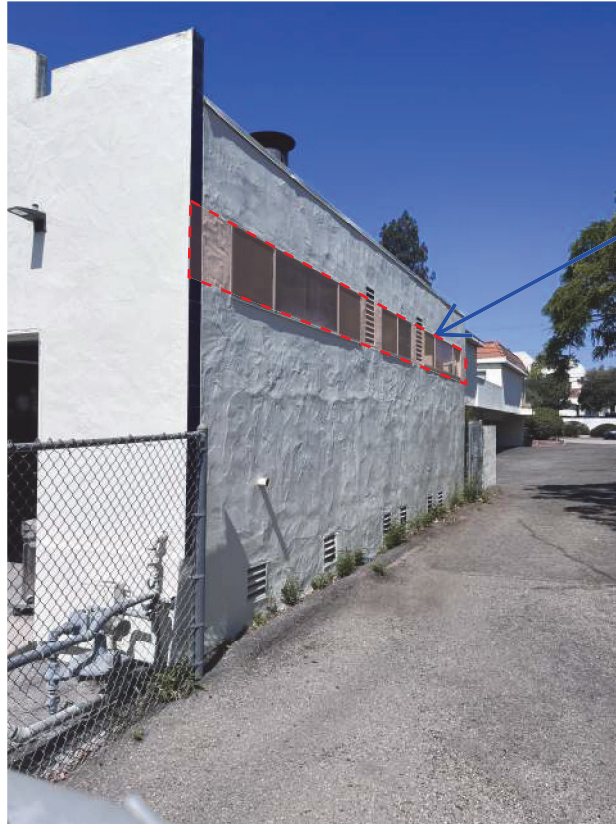
North-East Facing Wall

T&S/DRT: limited shear resistance in this wall with clerestory windows causing moderate vertical irregularity

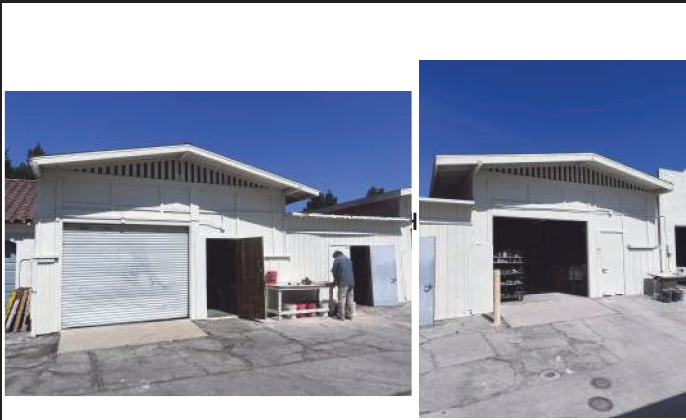
South-East Facing Wall

T&S/DRT: Limited clear distance to adjacent building and building end condition cause a potential for pounding

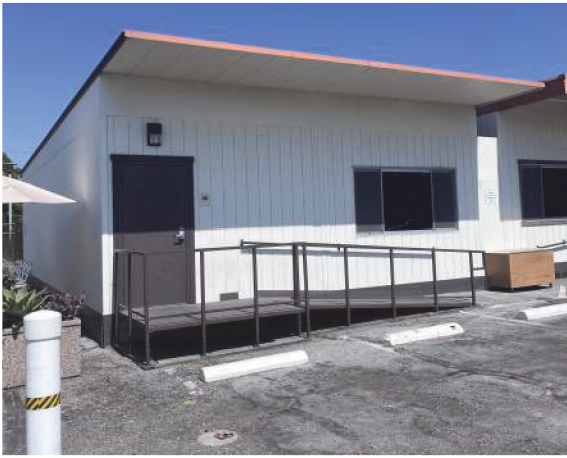
Building 37 - Damage to Exterior Wall Sheathing

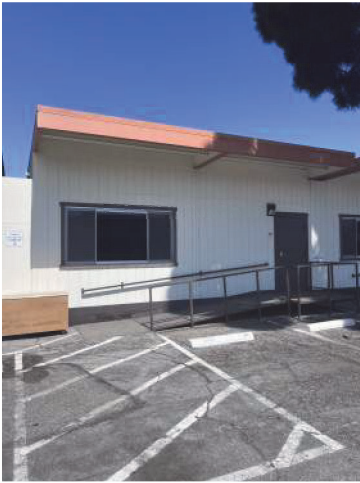
Damage to Metal Framing @ Foundation

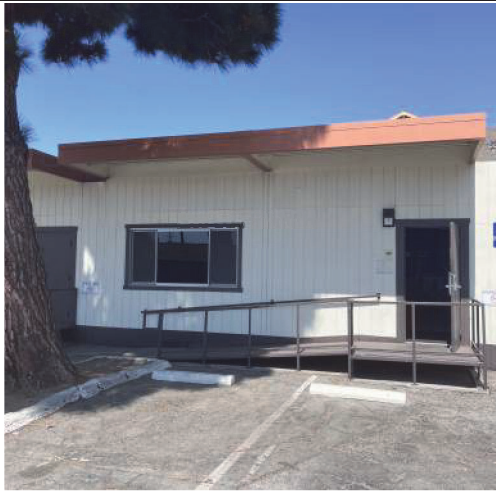
Damage to Plywood Roof Sheathing

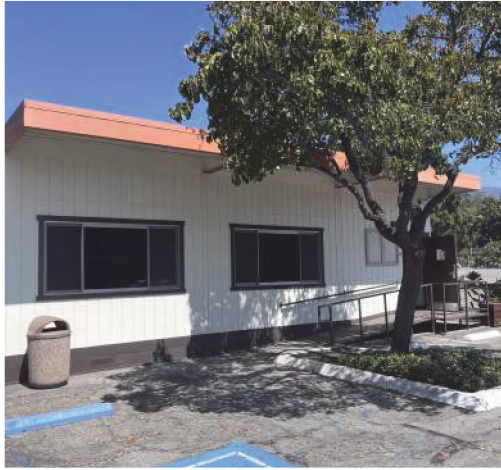
Damage to Plywood Skirting/Wood Sill

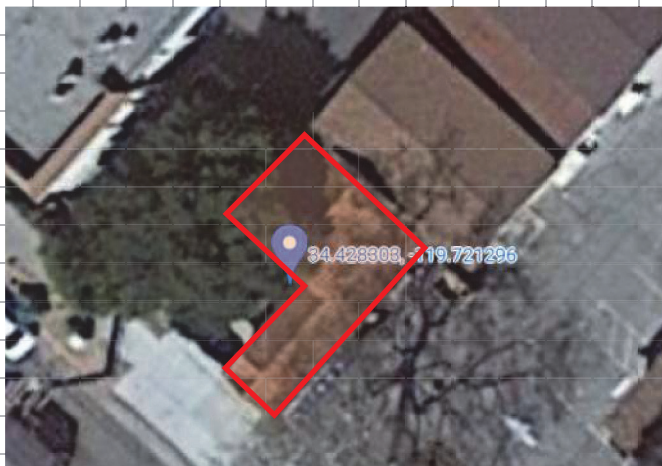
Site Conditions Observed:
Limited shear transfers from the roof to the masonry walls was observed. The limited clearance to the adjacent structure, along with being the end building, cause the potential for pounding.

T&S/DRT: Limited clear distance to adjacent building and building end condition cause a potential for pounding

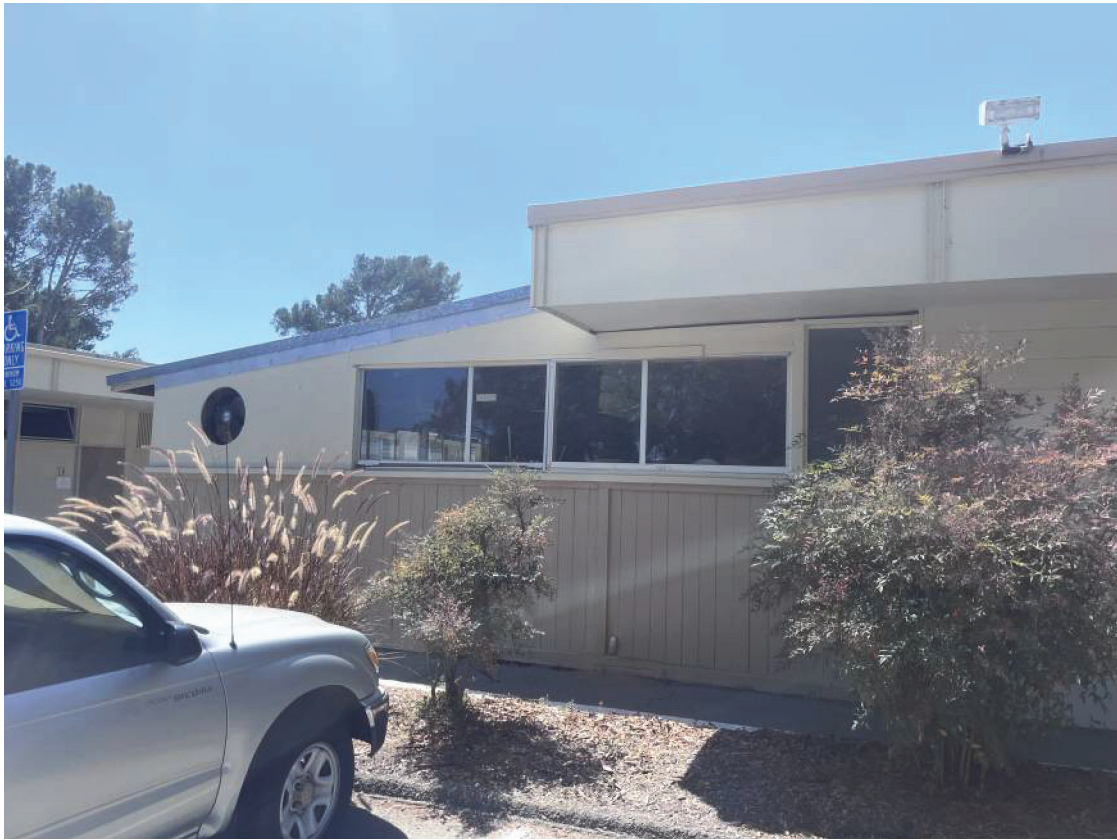
Addition @ South-East Corner - Exterior

Site Conditions Observed:
Exterior roof and patio addition/enclosure with no plans at south-east corner. No apparent seismic system at south face of addition.
*Limited shear resistance at clerestory windows (cantilever steel columns)
