SBCC Survey of Existing Buildings and Retrofit Plan

SANTA BARBARA CITY COLLEGE SEISMIC SURVEY

PRELIMINARY REPORT

May 31, 2023

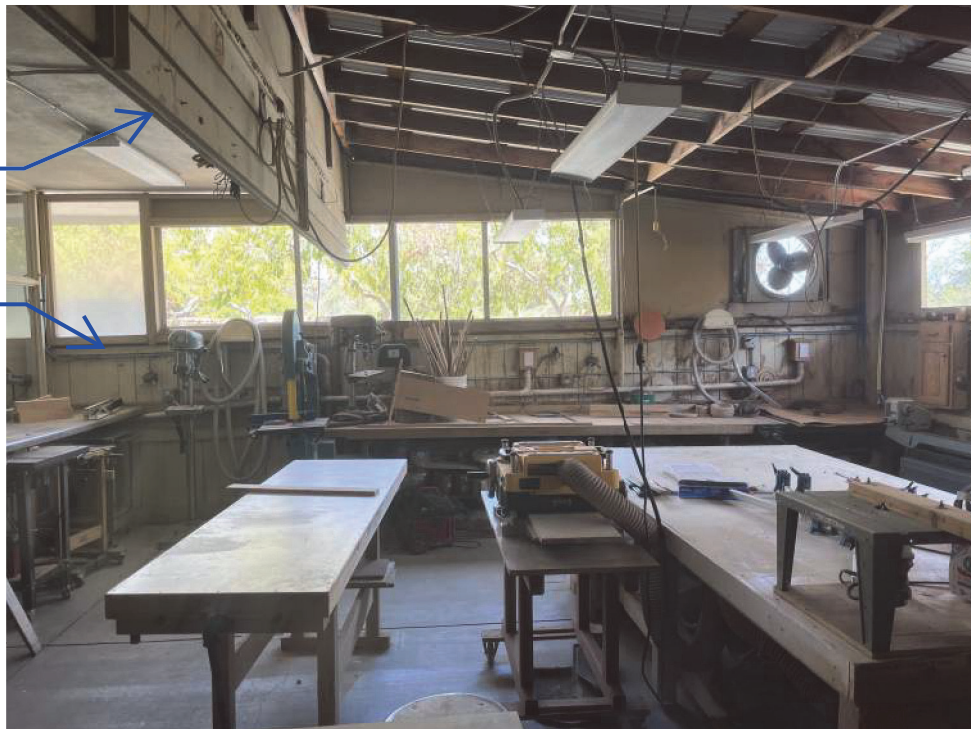
T&S/DRT: Original Face of Exterior Overhang

T&S/DRT: Original Patio Fencing

Addition @ South-East Corner - Interior

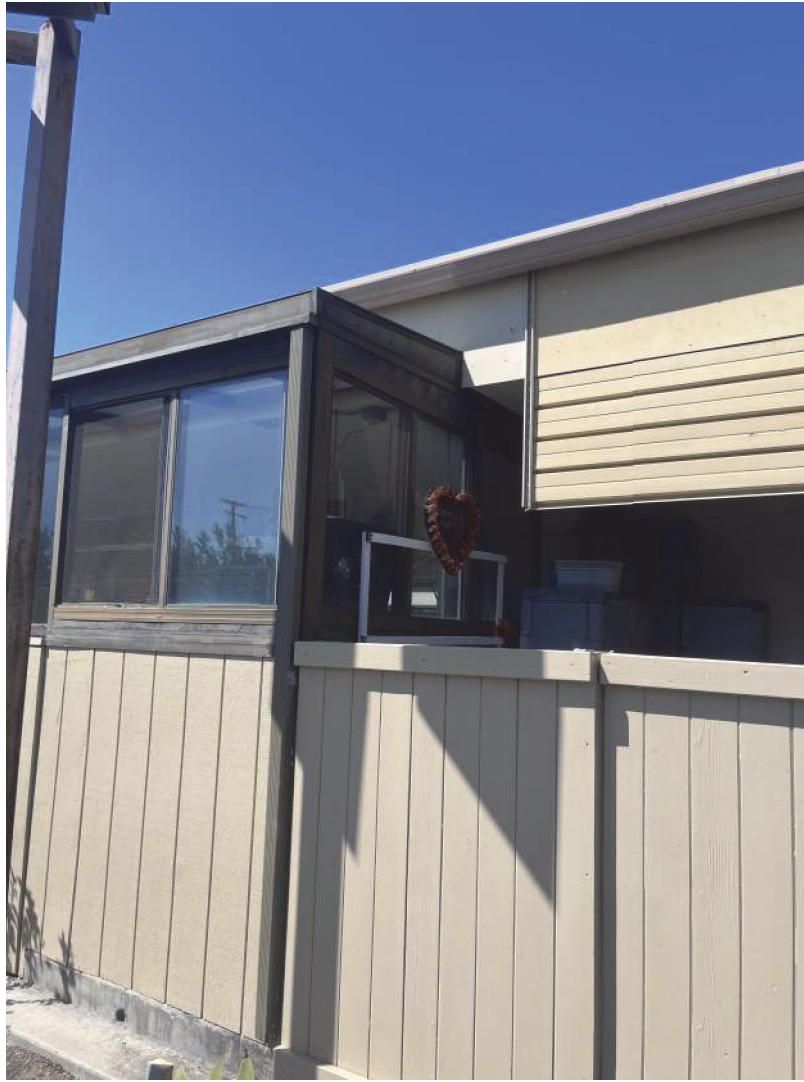
Addition @ South-West Corner - Exterior

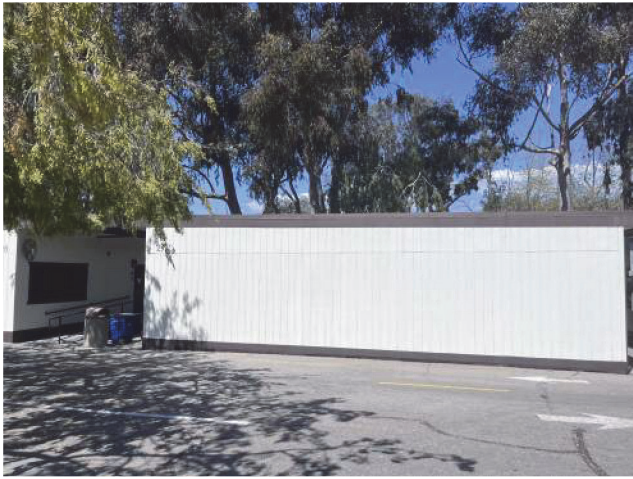
Site Conditions Observed:
Slight deterioration of cold-formed steel floor joists sitting on concrete footings and inadequate anchorage of floor system to strip footings.

Slight Deterioration of Floor System on Footing

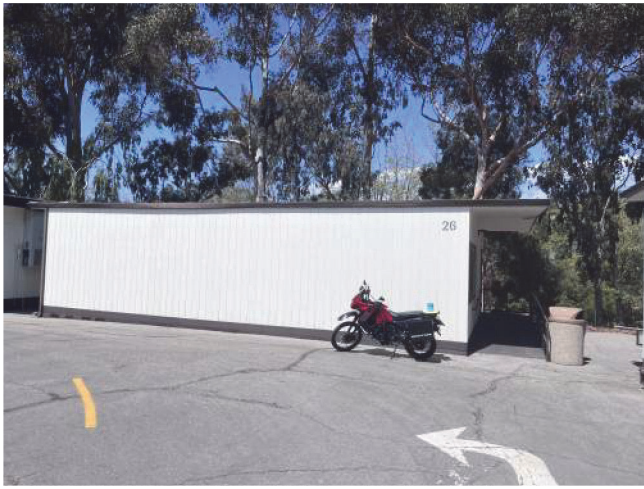
Site Conditions Observed:
Slight deterioration of wood sill-on-ground and cripple wall sheathing.

*Slight Deterioration of Wood Sill-On-Ground
and Cripple Wall Sheathing*

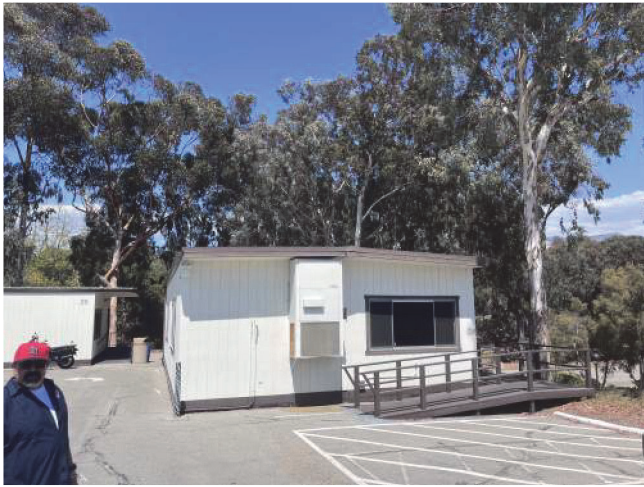
Site Conditions Observed:
Slight deterioration of cripple wall sheathing.

Slight Deterioration Cripple Wall Sheathing

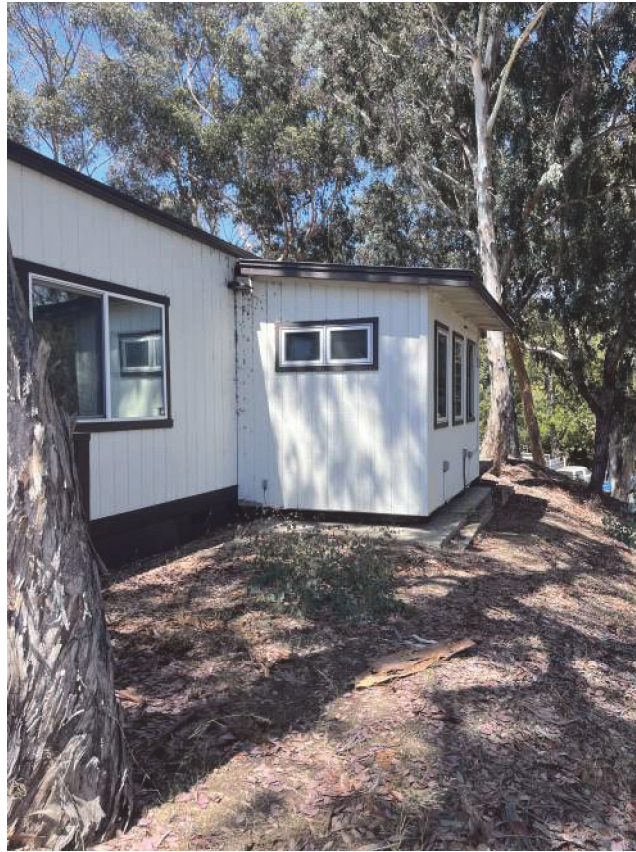
Site Conditions Observed:
Single room addition to East side with no physical plans or permits for review.

Single Room Addition to East Side

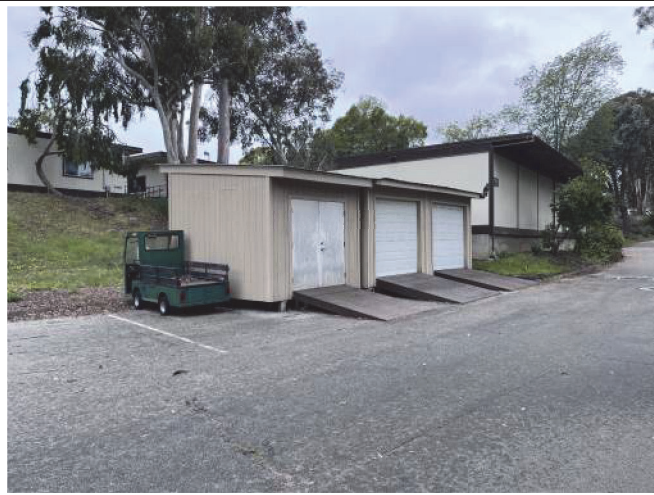
*Slight Deterioration to Cripple
Wall Sheathing*

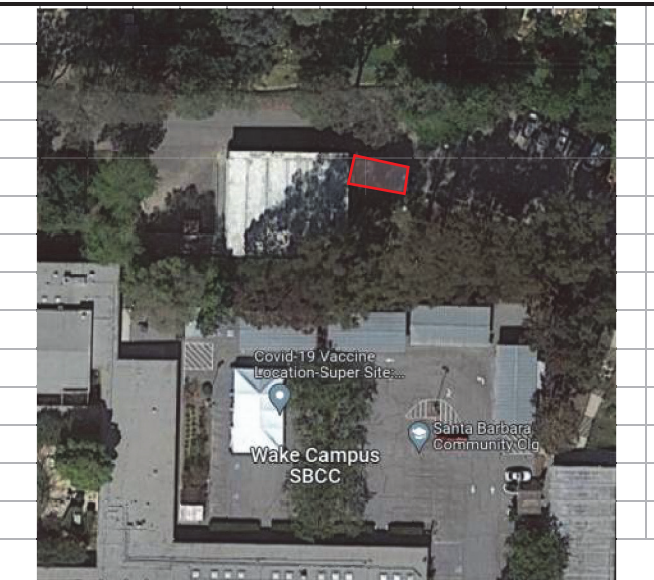
COMMENTS:
Multiple single-story structure with wood framed roof, floor, and walls supported on pressure treated lumber plates. Wood stud with plywood shearwall seismic system. Plywood sheathing for roof diaphragm.

Site Conditions Observed:
The structures are intermittently supported by pressure treated plates, with very limited lateral resistance towards the front face.

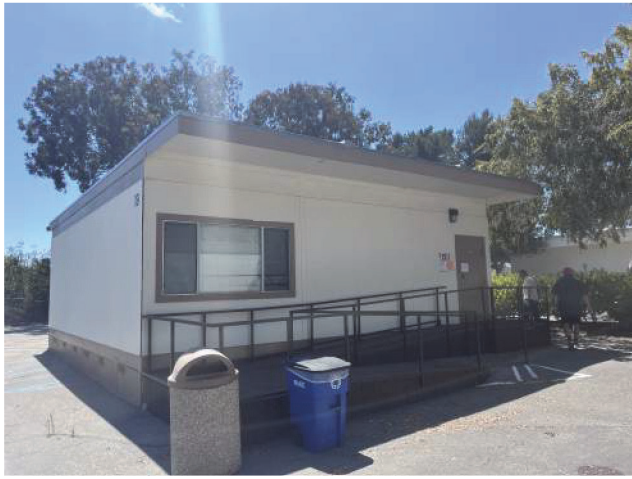
Site Conditions Observed:
Exterior stair, landing, and high roof addition west courtyard with no physical plans or permits for review.

*Stair, Landing, & High Roof Addition
@ West Courtyard*

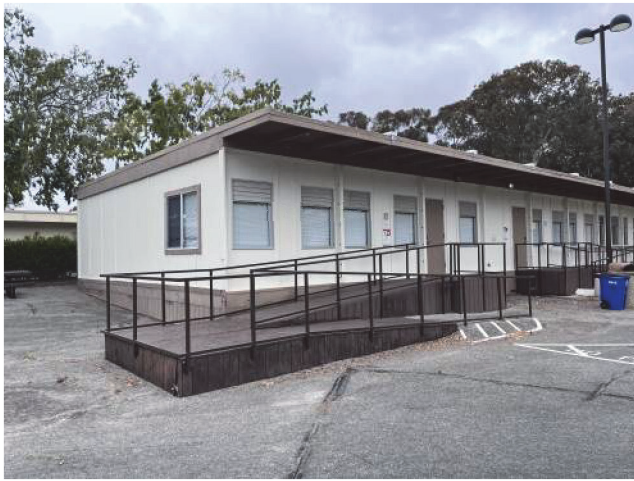
Slight Deterioration of Cripple Wall Sheathing

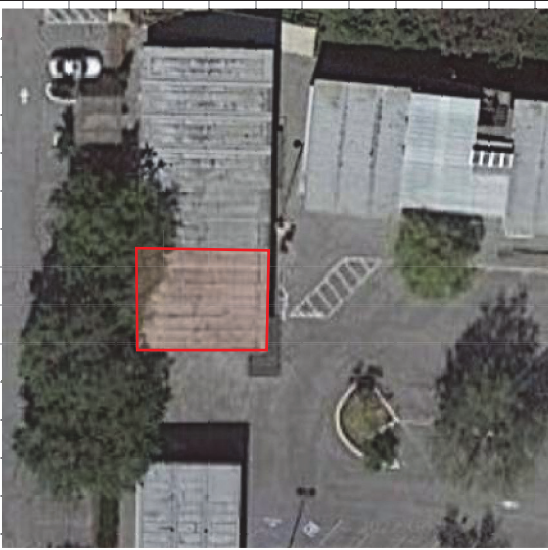
Site Conditions Observed:
The lack of space between the adjacent modular building, and the building being located at the end of the block, justify a pounding potential.

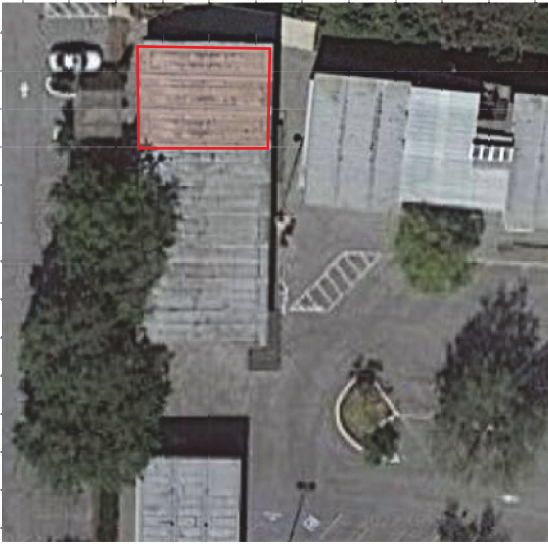
COMMENTS:
 Single-story structure with light gage steel framed roof, floor, and walls supported on pressure treated lumber plates Light gage steel with plywood shearwall seismic system. Corrugated steel sheathing for roof diaphragm. DSA approval was found on as-built plans from original location (Carpinteria) but no approved plans occur for current location.
 Site Conditions Observed:
 The lack of space between the adjacent modular building, and the building being located at the end of the block, justify a pounding potential.
